B. KALANDYK*, R. ZAPAŁA*, A. RAKOWSKA**

CHARACTERISTICS OF DEFECTS PRESENT IN INDUSTRIAL STEEL CASTINGS DUE TO METAL-MOULD REACTIONS

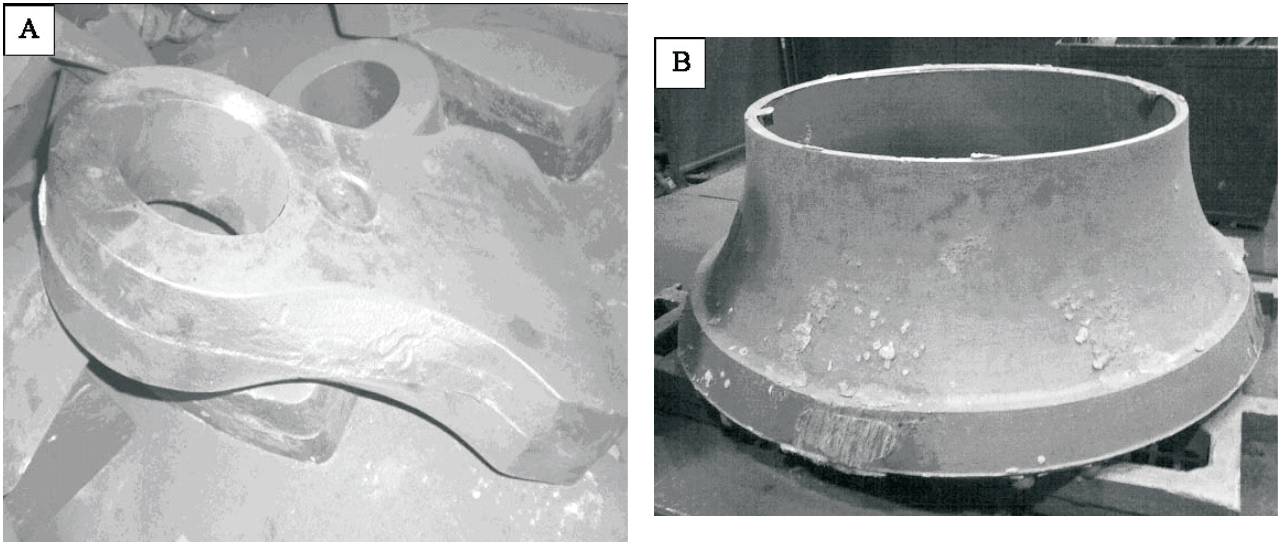
Some surface defects in steel castings are shown as an example in Figure 1.

Fig. 1. Examples of castings made from L120G13 steel – hammers cast from L120G13 steel (A); a cone cast from 120G13 steel

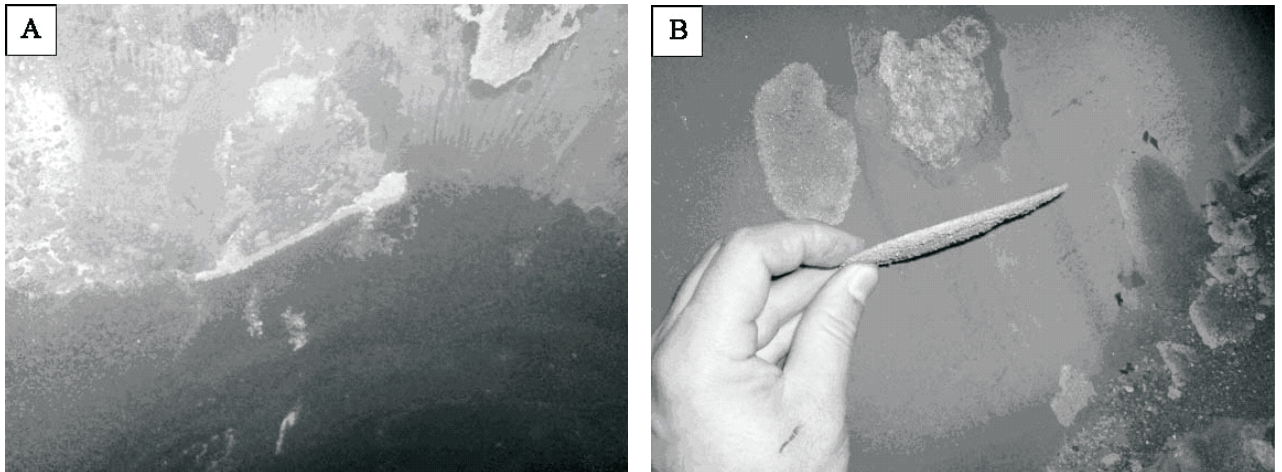
Fig. 2. Examples of surface defects in castings made from L120G13 steel

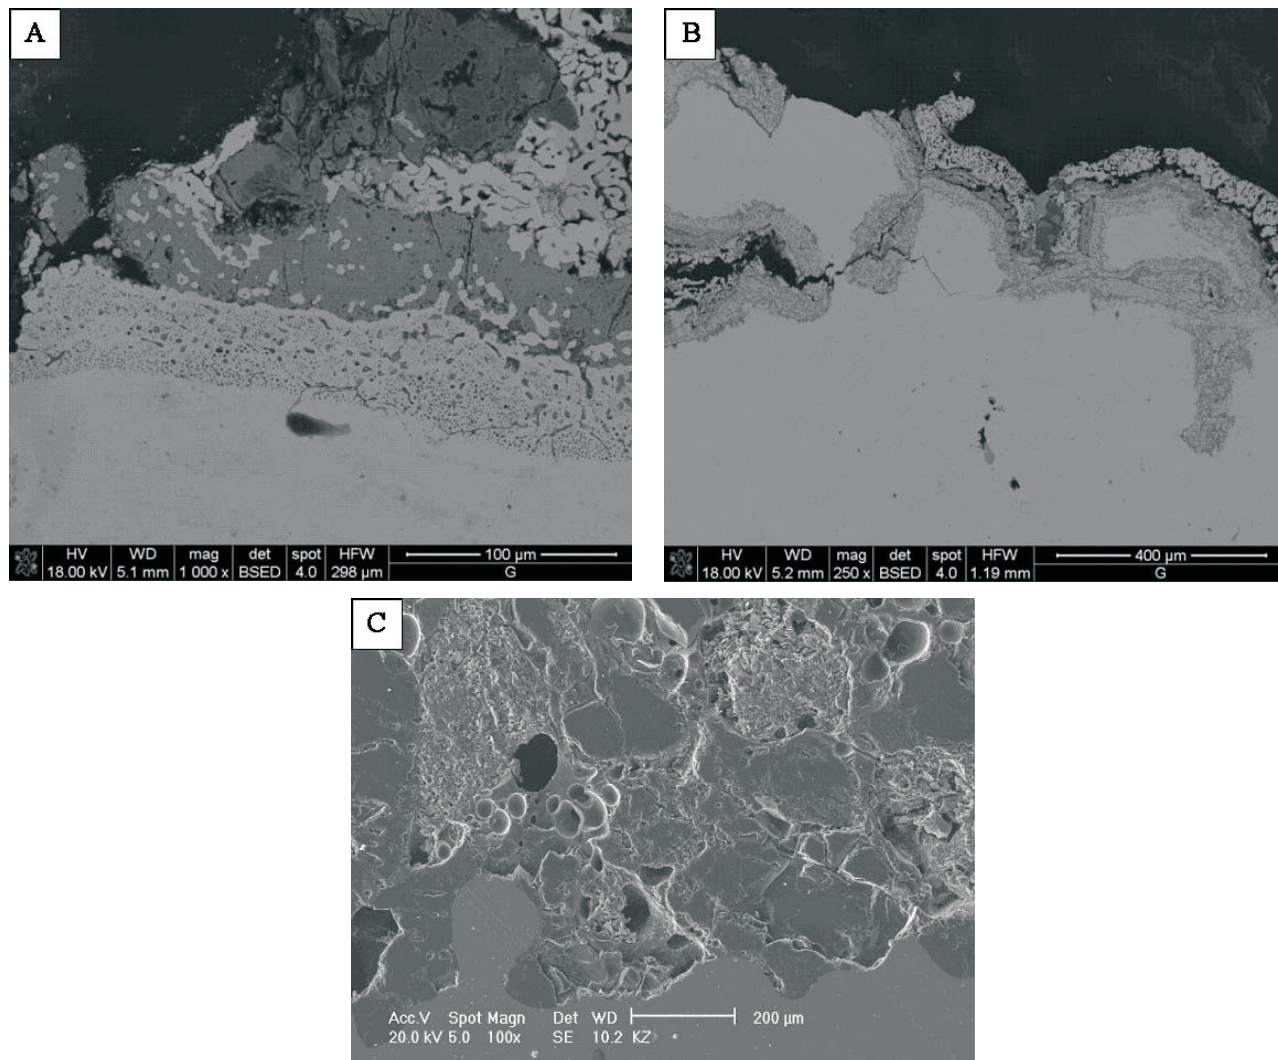
Figure 3 shows examples of surface defects present in castings and examined under the scanning electron microscope.

Fig. 3. Examples of images obtained from the examined regions by SEM-BSE

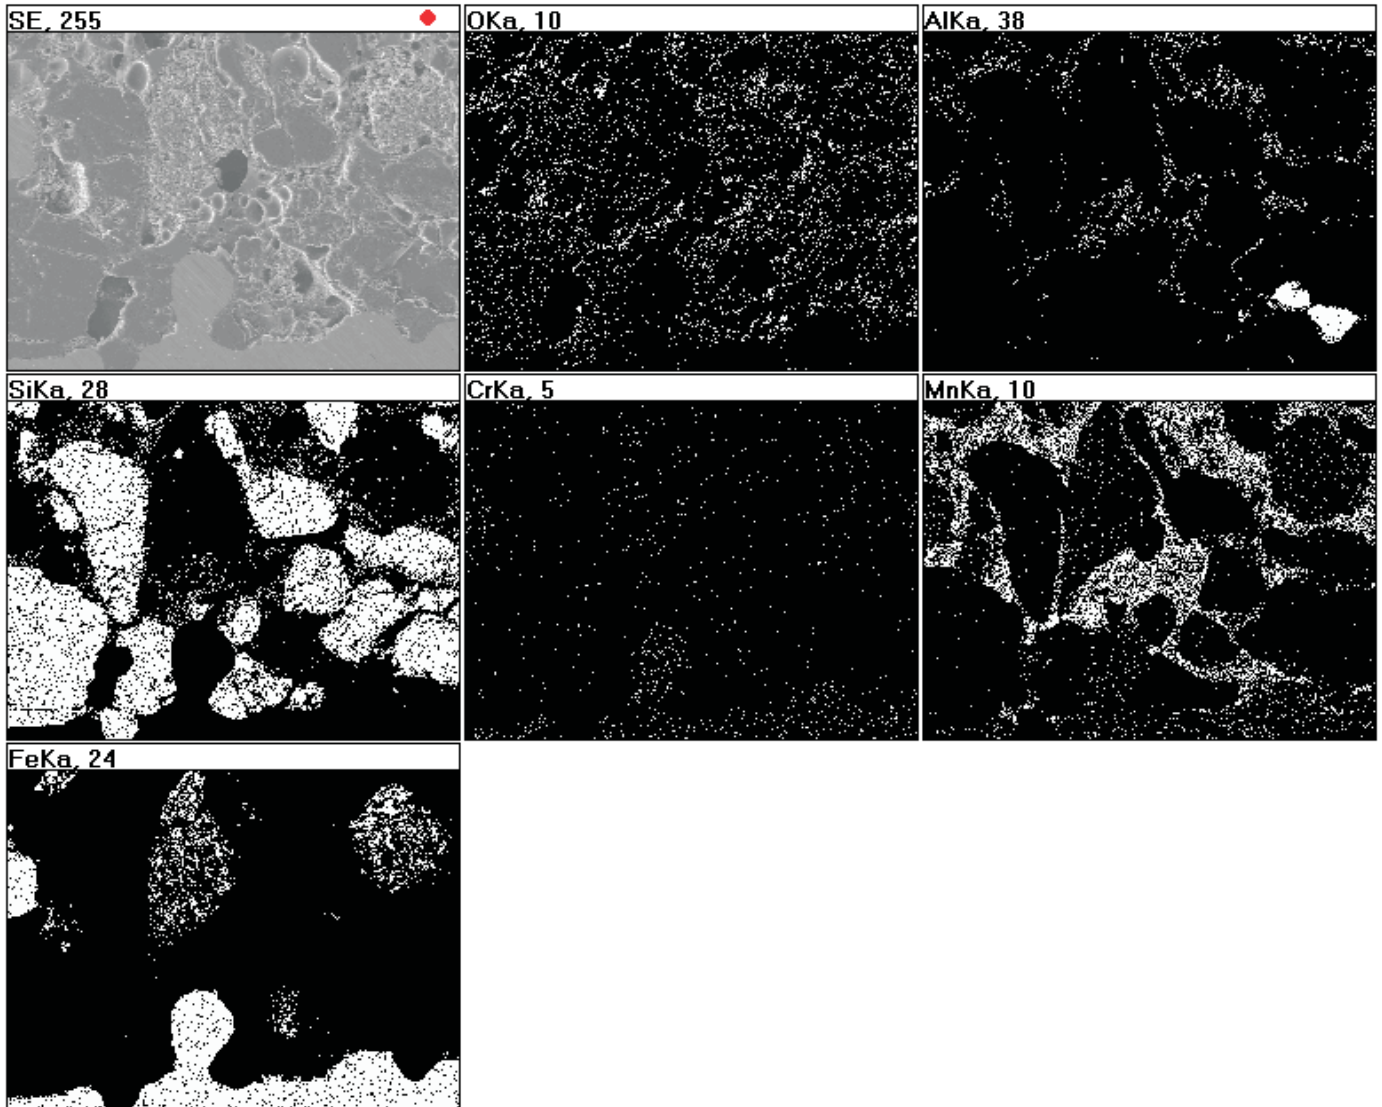
shown in Figures 4 and 5, respectively. From the surface distribution of elements it has been deduced that the defects are composed of the two characteristic areas. One area consists of the irregular silica sand grains, while the other is composed of a complex oxide phase containing elements like Mn, Si, O and Al.

Fig. 4. Mapping of elements distribution in the region of defect on the surface of the cast toothed wheel

In all the examined areas of oxide phases (present in various castings), the changing content of manganese has been observed (Figs. 4–6). The obtained results point out to an interaction between manganese contained in molten metal and silica present in the moulding sand. From an analysis of the chemical composition of complex oxide phases bonding the SiO_2 grains it has been concluded that these are the areas of highly non-homogeneous character as regards both structure (porosity) and chemical composition. The chemical elements prevailing in these regions included silicon, manganese and oxygen. Their concentration varied and depended on the steel grade of which the castings with defects had been made (carbon cast steel: 25-34%Si, 17-23%Mn, 24-36%O; Mn-Mo

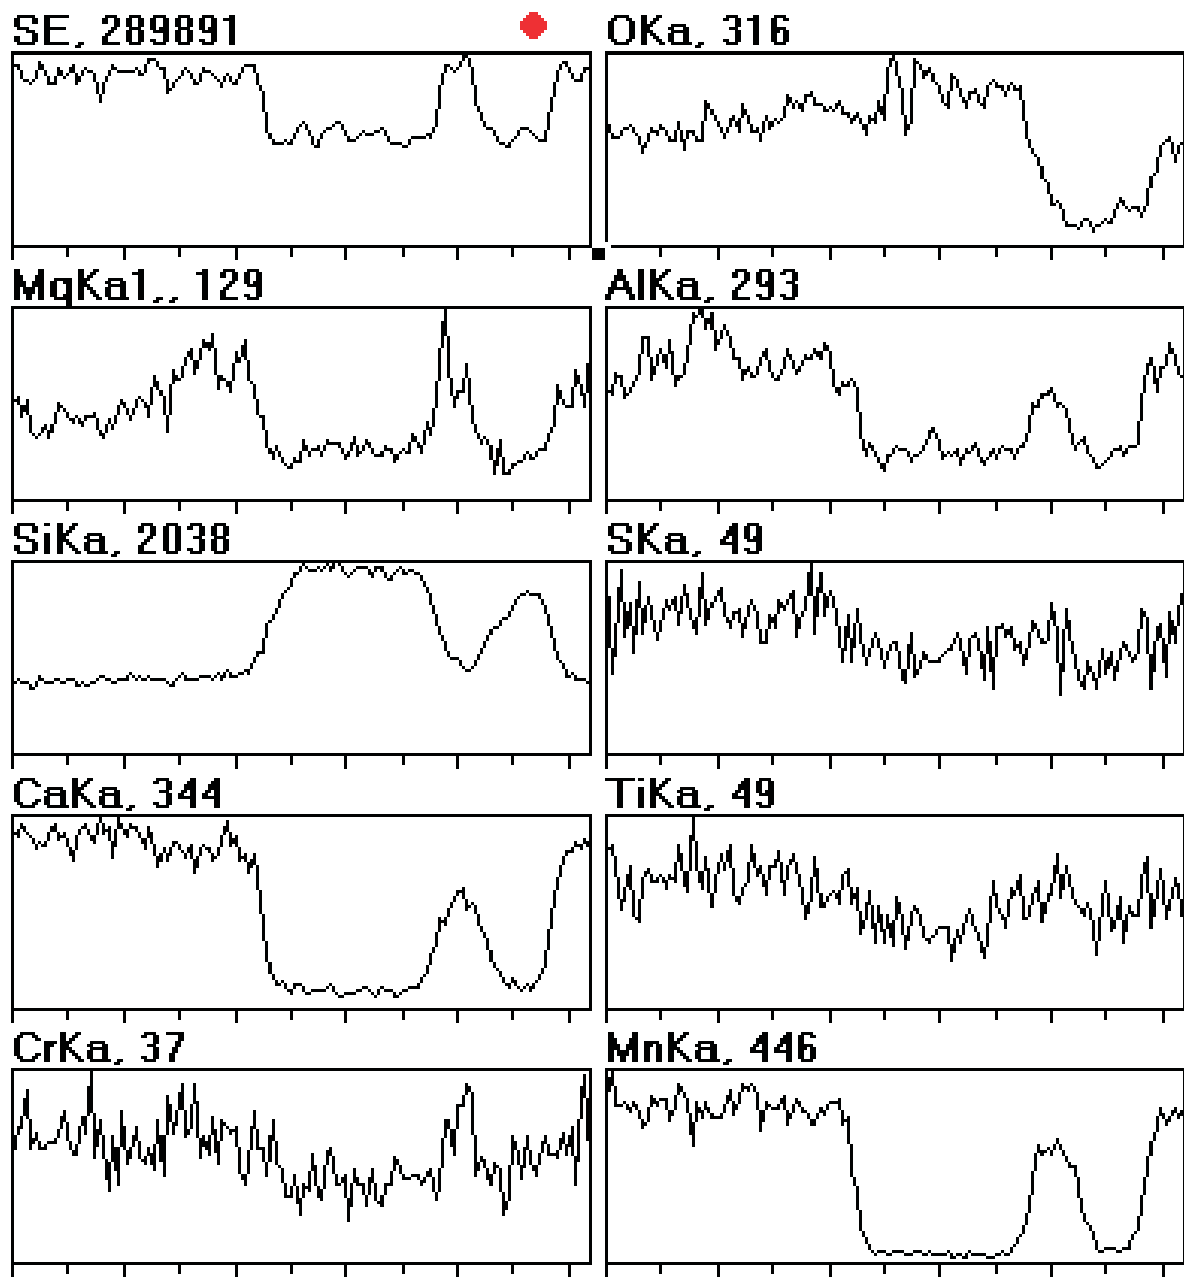
Fig. 5. Linear distribution through the region of oxide phase and SiO_2 grains

The high content of manganese in the examined regions of oxide phases may testify the fact that under the conditions applied when moulds are poured with molten metal (the temperature of about 1500-1600 °C), in places where the protective coating has either been damaged or applied in an incorrect way, the reaction of manganese oxidation (due to oxygen present in the atmosphere inside the mould cavity) and penetration of manganese vapours occurred. Due to the manganese affinity to oxy-

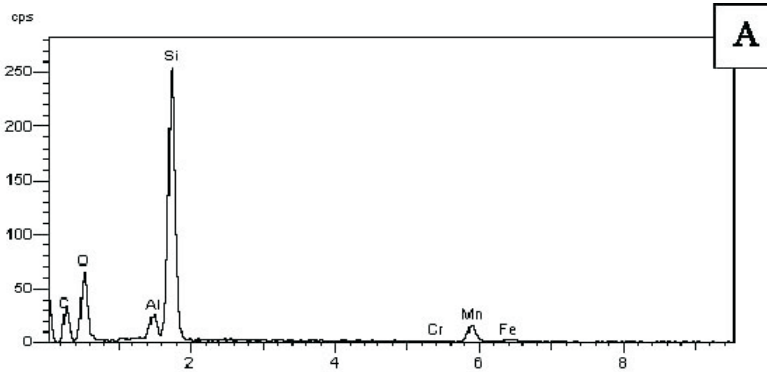
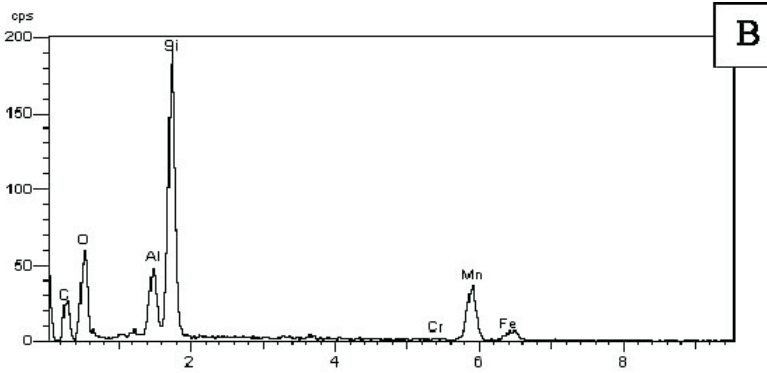
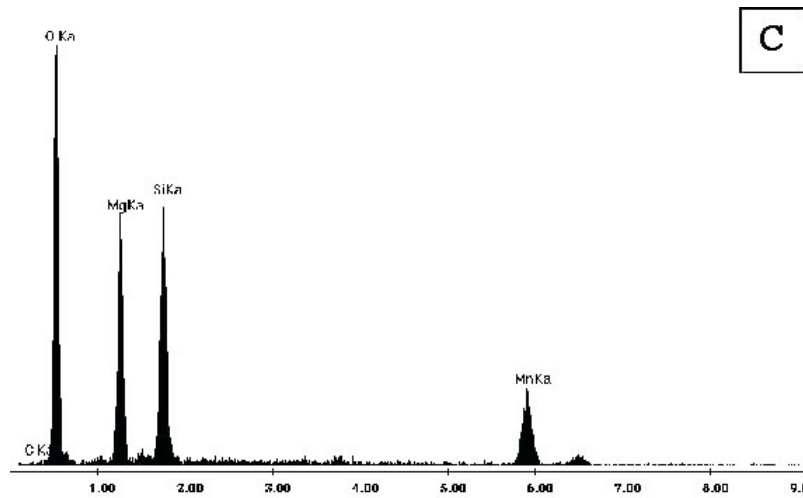
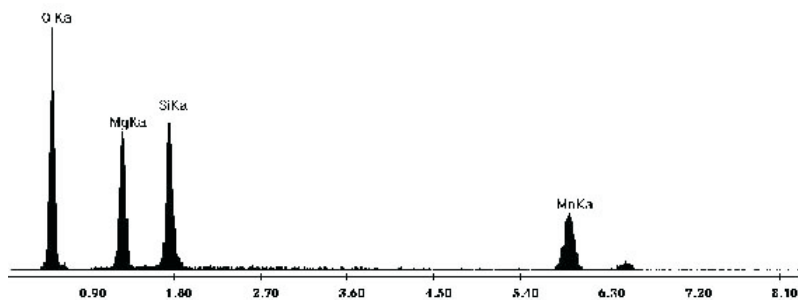
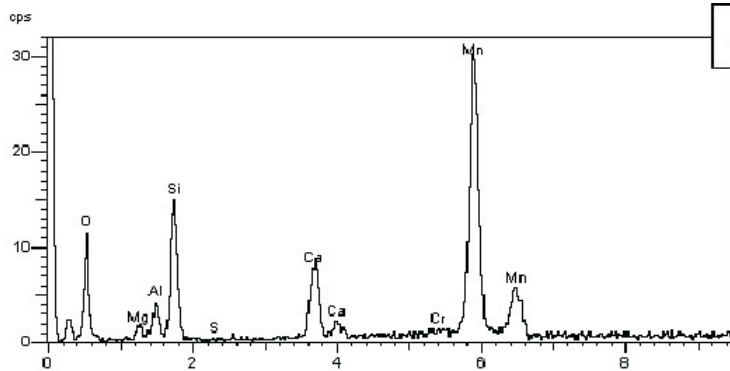
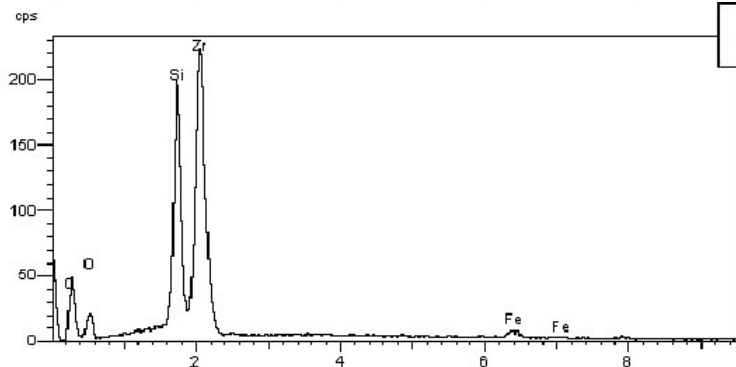
Rys. 6

cast steel: 33-41%Si, 32-39%Mn, 18-21%O, Hadfield cast steel: 39-40%Si, 27-40%Mn). Moreover, depending on the type of the coating applied, in some areas the presence of aluminium, iron and magnesium or zirconium was noted. This indicates that in the reactions between molten metal and moulding sand, manganese oxidation and the reaction between manganese oxide and silicon oxide play very important part. Oxidation of iron and aluminium is of secondary importance. The presence of a peak from aluminium leaves some doubts, considering the fact that the presence of this element may have its origin in either the deoxidation process, or in the technique used for preparation of the metallographic specimens (polishing with Al_2O_3).

Fig. 6. Representative EDS spectra from the examined regions of defects present on the surface of steel castings – the regions of silica sand grains (A); the regions of oxide phases (B); complex oxide phases containing Mg from the coating (C, D); complex oxide phases containing Mg or Zr from the coating (E, F)

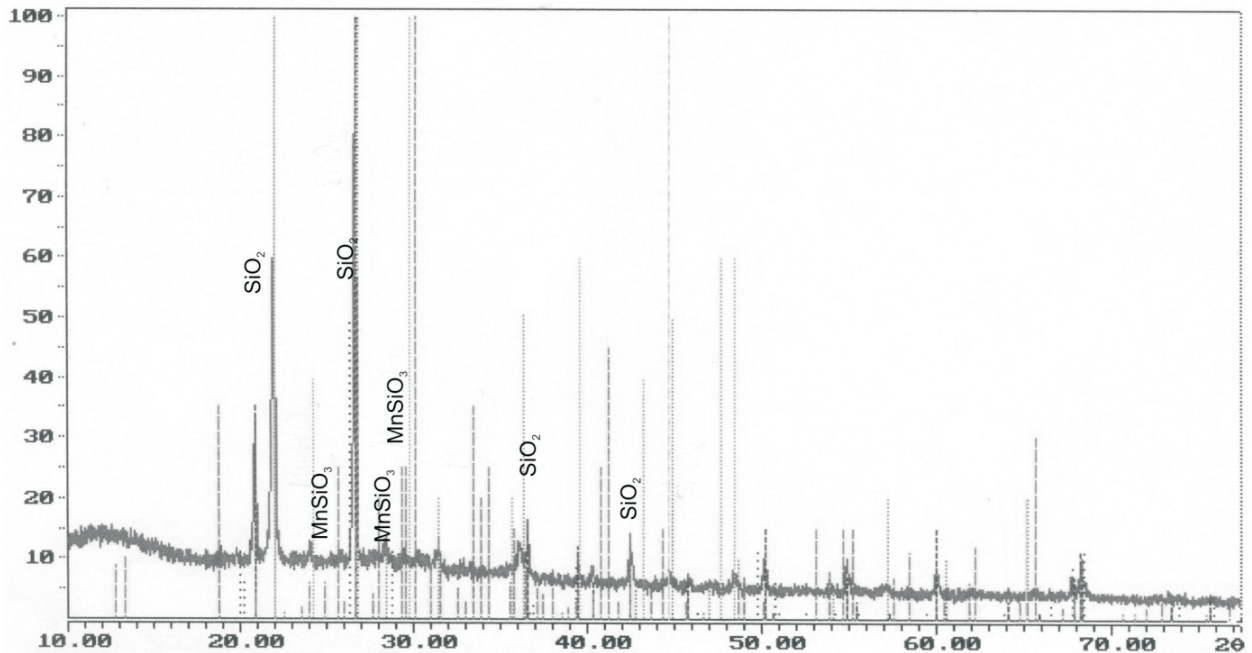
gen stronger than the affinity of iron, manganese oxide MnO is formed, and it reacts strongly with the constituents of the moulding sand (SiO_2). As a result of this reaction, silicates of a general formula $\text{Mn}_n\text{Si}_m\text{O}_{2m}$, are formed [4]. In the case of L120G13 cast steel, on the surface of the solidifying casting, an $\text{MnSiO}_3 + \text{Mn}_2\text{SiO}_4$ eutectic is formed [2]. The high content of silicon, manganese and oxygen can confirm this fact, while the X-ray phase analysis confirms the presence of MnSiO_3 (Fig.7).

Fig. 7. An example of diffraction pattern from the region of surface defect [7]
