THE SERVICE LIFE OF THE REPAIR WELDED JOINT OF Cr-Mo / Cr-Mo-V

This paper presents the evaluation of the service life of dissimilar repair welded joint from Cr-Mo/Cr-Mo-V steel after 200,000 h service under creep condition. The investigations of microstructure using scanning electron microscopy, investigations of mechanical properties at room and elevated temperature as well as creep tests of the basic material from Cr-Mo and Cr-Mo-V steel and welded joint from these steels were carried out. The investigations allowed the time of further safe operation of the repair welded joint in relation to the residual life of the materials to be determined. The evaluation of residual life and disposable residual life, and thus the estimation or determination of possible time of further safe operation, is crucial when the elements are operated much beyond the design work time.

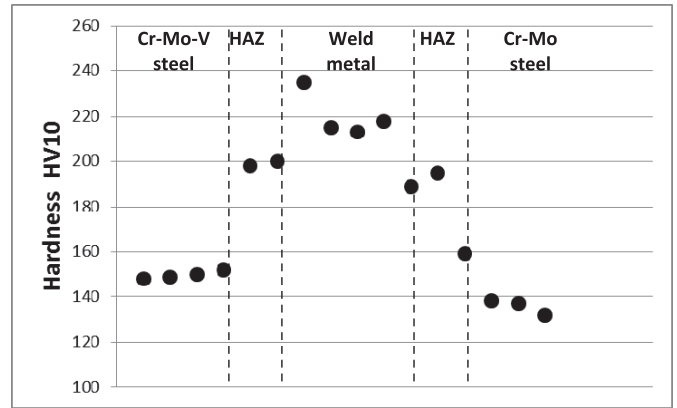
Fig. 1. Results of hardness measurements of dissimilar circumferential repair welded joint (Cr-Mo-V/Cr-Mo)

The hardness measurement through individual zones of the joint revealed no sudden changes. The maximum difference in hardness from Cr-Mo steel parent material through HAZ, weld, HAZ to Cr-Mo-V steel parent material is approx. 110 units and does not exceed the maximum acceptable value of 350 HV10.

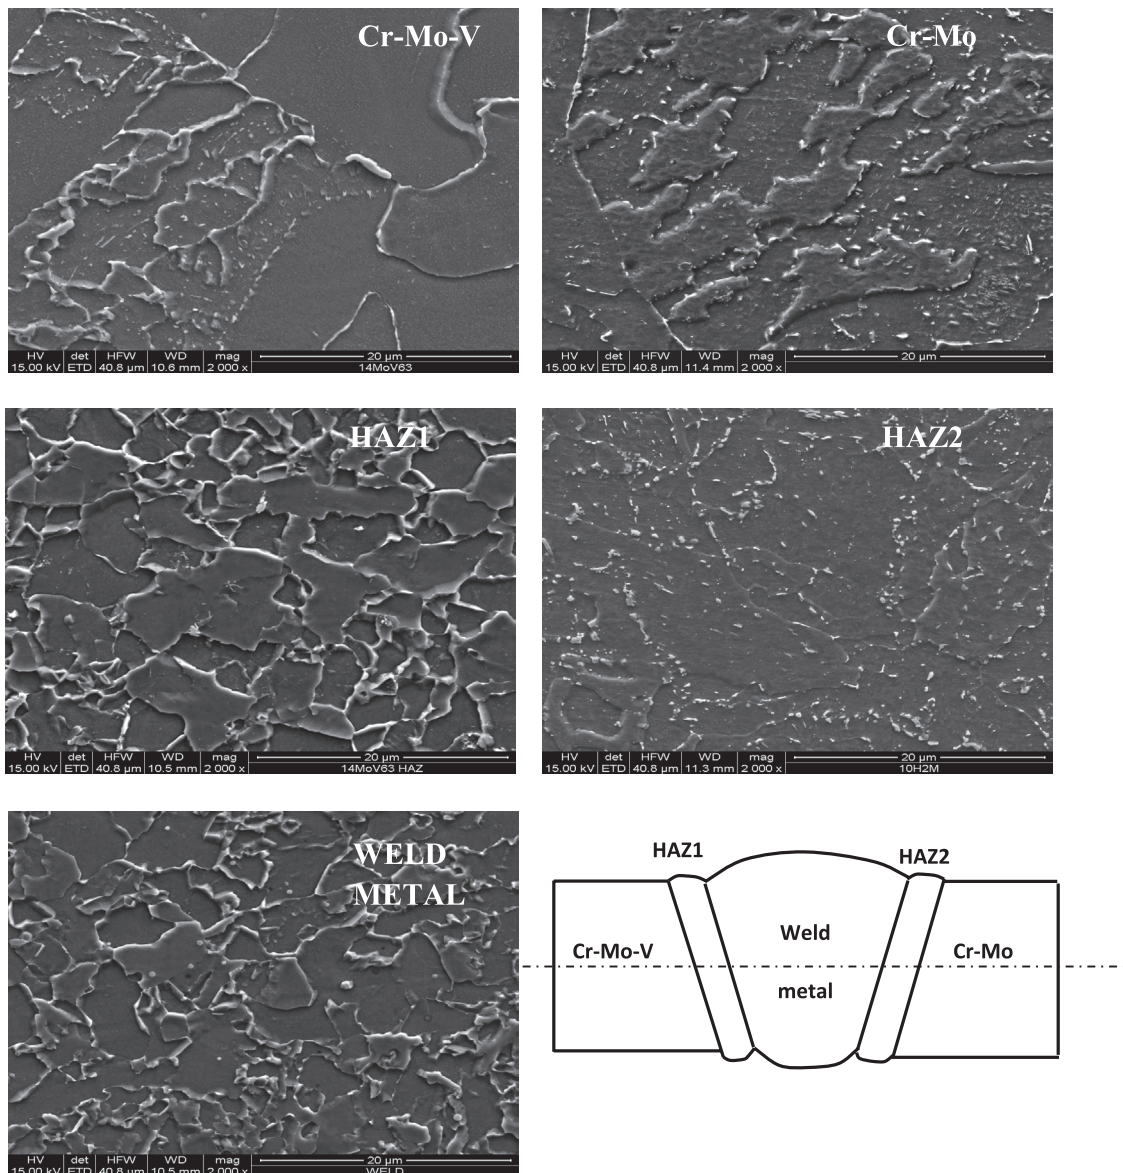
Fig. 2. Microstructure of the material of repair welded joint elements

Test area	Description of microstructure Material condition – exhaustion degree
Parent material 13HMF steel	Ferritic-bainitic microstructure. Partially coagulated bainitic areas. Precipitations of different size at the ferrite grain boundaries. Inside the ferrite grains, there are very fine evenly distributed precipitates. No discontinuities and micro-cracks are observed in the microstructure. No initiation of damaging processes is observed. Bainitic areas: class I, precipitates: class a <u>Damaging processes: class O</u> CLASS 1/2, EXHAUSTION DEGREE: approx. 0.3
Parent material 10H2M steel	Ferritic-bainitic microstructure. Partially coagulated bainitic areas. Fine precipitations at the ferrite grain boundaries. Mostly very fine precipitations inside ferrite grains. No discontinuities and micro-cracks are observed in the microstructure. No initiation of damaging processes is observed. Bainitic areas: class I, precipitates: class a <u>Damaging processes: class O</u> CLASS 1/2, EXHAUSTION DEGREE: approx. 0.3

Heat-affected zone, weld – repair joint	Heat-affected zone microstructure. No discontinuities and micro-cracking are found in the microstructure.
