WEAR MECHANISMS ANALYSIS OF DIES USED IN THE PROCESS OF HOT FORGING A VALVE MADE OF HIGH NICKEL STEEL

The study presents a durability analysis of dies used in the first operation of producing a valve-type forging from high nickel steel assigned to be applied in motor truck engines. The analyzed process of producing exhaust valves is realized in the forward extrusion technology and next through forging in closed dies. It is difficult to master, mainly due to the increased adhesion of the charge material (high nickel steel) to the tool's substrate. The mean durability of tools made of tool steel W360, subjected to thermal treatment and nitriding, equals about 1000 forgings. In order to perform a thorough analysis, complex investigations were carried out, which included: a macroscopic analysis combined with laser scanning, numerical modelling by FEM, microstructural tests on a scanning electron microscopy and light microscopy (metallographic), as well as hardness tests. The preliminary results showed the presence of traces of abrasive wear, fatigue cracks as well as traces of adhesive wear and plastic deformation on the surface of the dies. Also, the effect of the forging material be

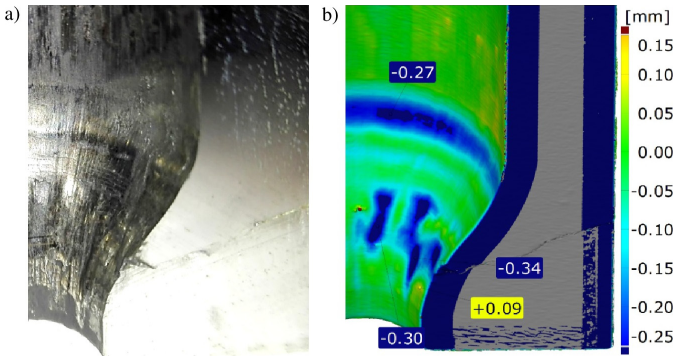
Fig. 4. The tool surface after 1900 working cycles: a) macro view, b) comparison of laser scan image with CAD model

The highest wear was observed on the surface of the tool which worked through the biggest number of forging cycles, i.e. 1900 (Fig. 4). The material losses reach 0.30–0.34 mm and are extensive. On the surface, we can also notice cracks and traces of plastic deformation in the surface layer, visible on the surface in the form of deformed cracks as well as protruding fragments constituting the allowance whose values reach over 0.15 mm.

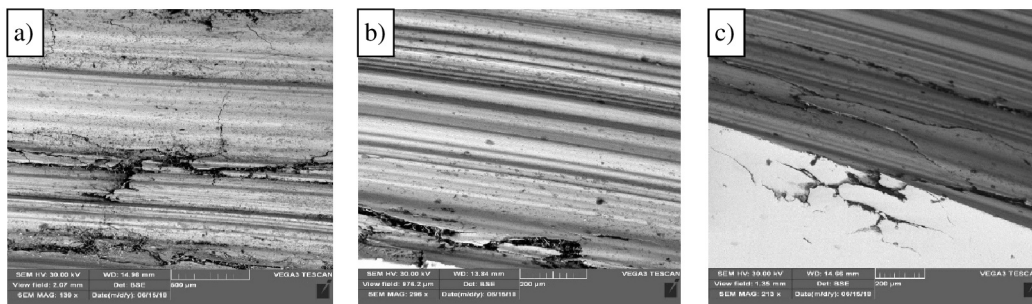
The analyzed area (Fig. 16) contains numerous grooves of different widths 25-100 μm and depths 5-25 μm . We can also notice cracks originating from thermal fatigue. The cracks propagate to the depth of about 300 μm from the surface. On the surface, it is possible to see sticking of the plastically deformed material (Fig. 16c).

Fig. 16. Analysis of selected areas in zone II for a tool which has produced 900 forgings

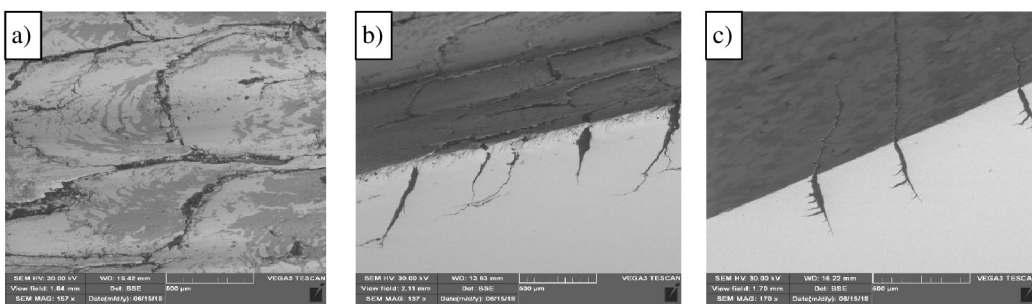
Fig. 17. Analysis of zone II for a tool which has produced 1900 forgings

The analyzed area (Fig. 17) contains numerous grooves of different widths 500-750 μm and depths 25-50 μm . We can also notice cracks originating from thermal fatigue. The cracks propagate to the depth of about 500 μm from the surface. On the surface, it is possible to see sticking of the plastically deformed material (Fig. 17a-b). In the groove and crack areas, we can observe a material in the form of oxides and impurities from the production process. The cracks filled with iron oxides originating from the tool material were confirmed by the EDX analysis. In the area of transition into the arc section, cracks without plastic deformation are visible (Fig. 17c). Their depth is about 350-500 μm . They are also filled with iron oxides coming from the tool material. This proves a relatively high temperature of the tool in these areas.

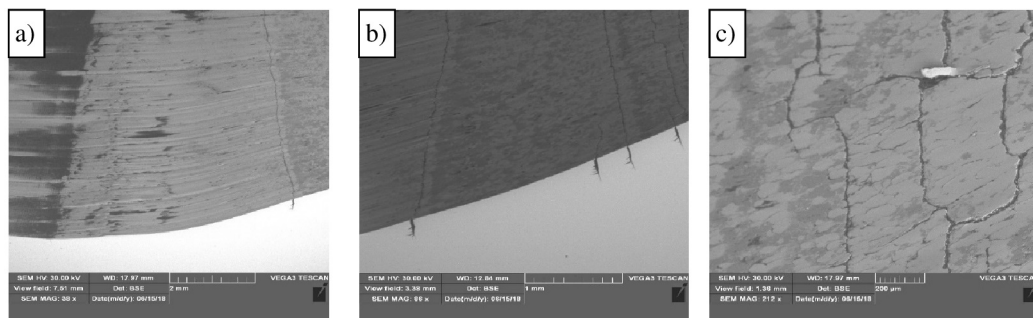
The analyzed area (Fig. 19) contains numerous grooves in the radial area, which fade in the further section of the tool (Fig. 19a). In the transition zone, we can notice material cracks originating from thermal fatigue (Fig. 19b). Cracks of this type

Fig. 19. Analysis of zone III for a tool which has produced 1900 forgings

were not visible for the tool which had produced 900 forgings. Also, it is possible to notice a network of primary and secondary cracks (Fig. 19c) in the transition area, covered with a small amount of oxides.

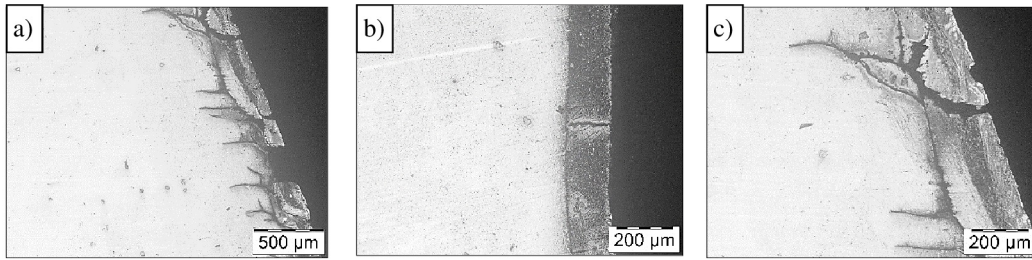
For the tools after a larger number of forgings, the cracks are much deeper; also, as it can be observed in Fig. 21a and

Fig. 21c, material losses as well as a strongly deformed material in the surface layer are present. We can also notice a tendency for spalling of the diffusive nitrided layer for the tools which have produced a larger number of forgings.

Fig. 21. Exemplary microstructural images with a visible nitrided layer and numerous cracks. The tool has produced 1900 forgings: a) in zone I, b) in zone II, c) in zone III
