A. ZIEWIEC\*, E. TASAK\*, M. WITKOWSKA\*, K. ZIEWIEC\*\*

## MICROSTRUCTURE AND PROPERTIES OF WELDS OF SEMI-AUSTENITIC PRECIPITATION HARDENING STAINLESS STEEL AFTER HEAT TREATMENT

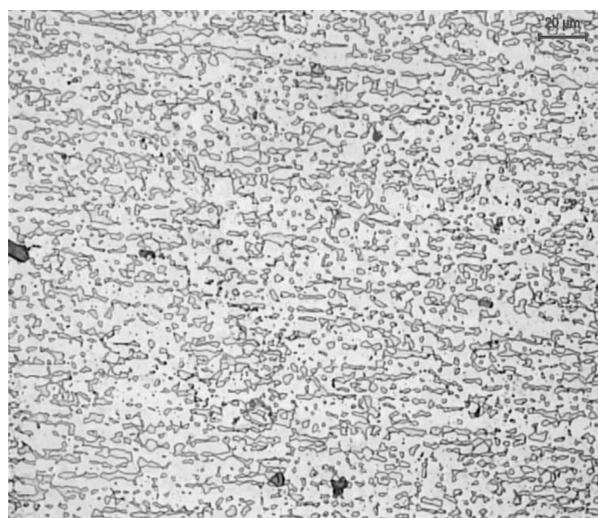
Fig. 1. Microstructure of the base material,  $\delta$  ferrite in austenite matrix. Sample without heat treatment. Electrolytic etching in 10% CrO<sub>3</sub>

Figures 1÷6 presents exemplary microstructures of the base material and the different areas of the welded joint. The microstructure of the base material observed under light microscope consists of  $\delta$  ferrite surrounded by the austenitic-martensitic matrix (Fig. 1). The larger ferritic areas located at the grain boundaries within the martensite and austenite as well as inside the boundaries of the plate-like austenite are observed in the high temperature region of the heat affected zone (Fig. 2). The microstructure of the weld

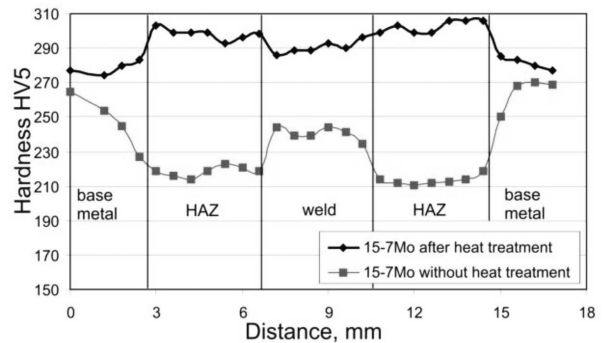
Fig. 10. Hardness distribution on the cross-section of the joint after welding without cold treatment and after heat treatment that consisted of annealing at 760°C and aging at 566°C

The hardness tests were performed at mid-height of the weld. Figure 10 shows comparison of the results of hardness measurements for the samples without cold treatment that were subsequently heat treated and not heat treated. Figure 10 shows that the heat treatment increases hardness of the weld to 300HV5. This value is slightly higher than the hardness of the welded material that was annealed and had the hardness ca. 280 HV<sub>5</sub>. Cooling the weld to the temperature of the liquid nitrogen causes transformation of the austenite into martensite in the heat affected zone and increases hardness number ca. 20 HV<sub>5</sub>. The precipitation hardening at 510°C causes further increase of the hardness level to ca 290 HV<sub>5</sub> (Fig. 11).

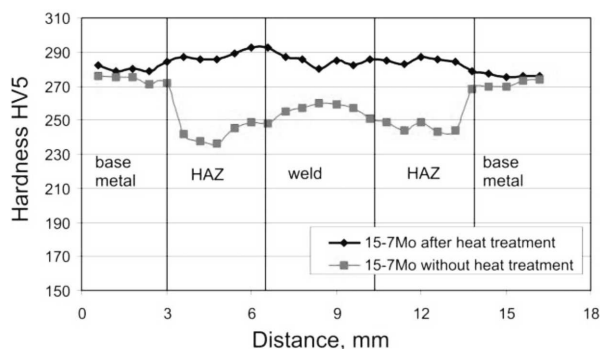
Fig. 11. Hardness distribution on the cross-section of the joint after cold treatment and aging at 510°C
