XU-YANG WANG<sup>1</sup>, CHENG-WANG TANG<sup>2</sup>, WEN-JIAO DAN<sup>2\*</sup>**EXPERIMENTAL INVESTIGATION OF HYDROGEN EMBRITTLEMENT IN POST-FIRE Q690 WELDMENTS**

*Keywords:* Q690 weldment; Heat treatment; mechanical properties; hydrogen embrittlement sensitivity; fracture morphology

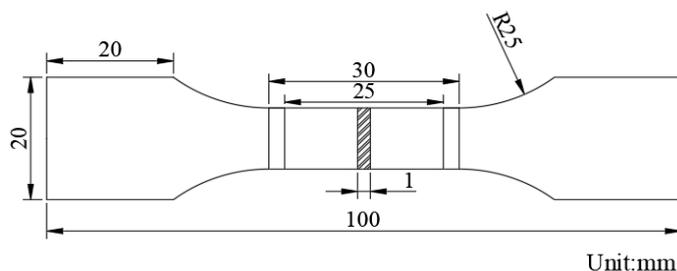
Fig. 1. Schematic diagram of weldment specimen and beveling

The material selected for this study was Q690 high-strength steel weldments. The sample consisted of sheet metal with a total length of 100 mm and a thickness of 4 mm. The chemical composition of the material is provided in TABLE 1, while the sample dimensions are illustrated in Fig. 1 [19]. A 25 mm hydrogen charging section was positioned at the center of the sample. Prior to welding, a 60° V-groove with a depth of 2.5 mm was milled along the joint interface. The groove dimensions are depicted in Fig. 2.

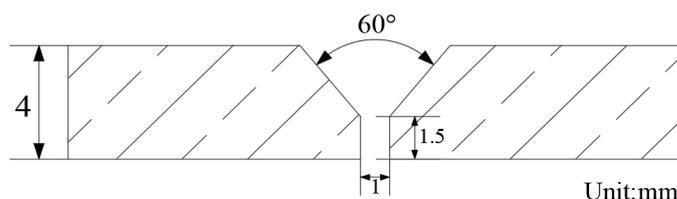
Fig. 2. Welding Bevel Schematic

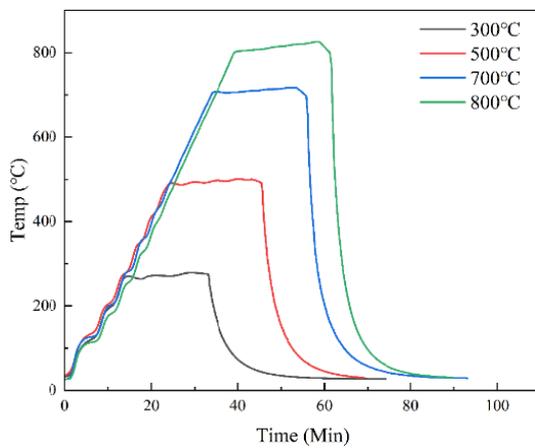
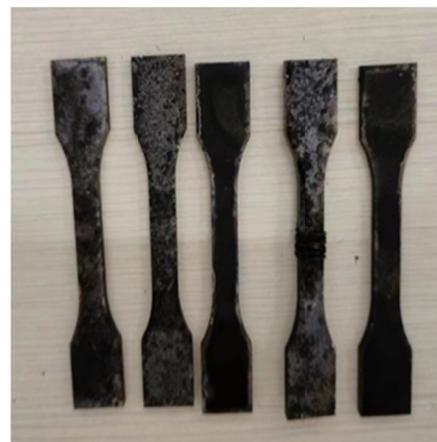
Fig. 3. Specimen heat treatment (a) Heat treatment process data and (b) Specimens after the heat treatment

two additional samples were used for fracture analysis. The Q690 high-strength steel welded parts were heated in a muffle furnace at a rate of 20°C/min to target temperatures of 300°C, 500°C, 700°C, and 800°C. Each sample was maintained at the designated temperature for 20 minutes before being removed and air-cooled to room temperature. The experimental data and corresponding specimens are shown in Fig. 3.

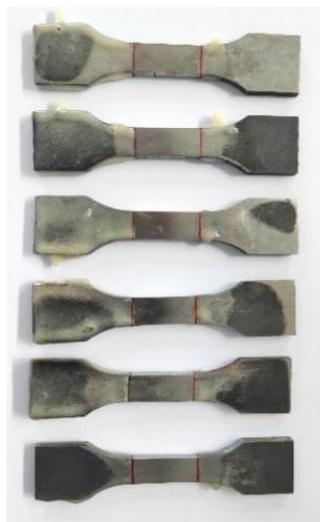
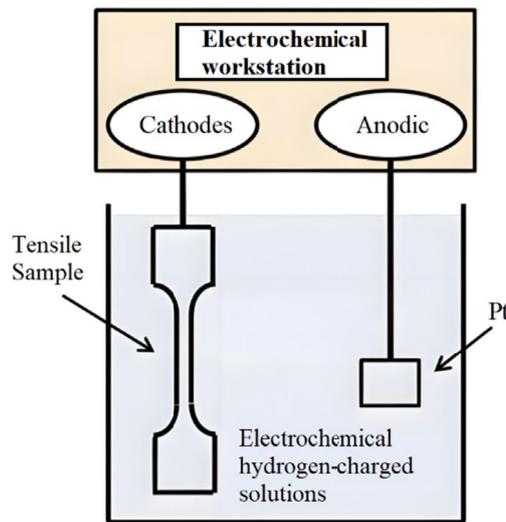
Fig 4. Q690 high strength steel weldment specimen drawing (a) Specimens for Electrochemical hydrogen charging and (b) Schematic diagram of Electrochemical hydrogen charging

The Q690 welded parts were polished using SiC sandpaper, progressing sequentially from grit 200 to grit 2000. The polished samples were then rinsed with alcohol and dried with cold air. The remaining sections of the test pieces were coated with epoxy resin to prepare a defined hydrogen charging surface. The hydrogen charging section measured 25 mm in length and 10 mm in width, resulting in a total charging area of 2.5 cm<sup>2</sup>, as illustrated in Fig. 4(a).

two compounds. During the hydrogen charging experiments, the sample was connected to the cathode, and a platinum plate was used as the anode. The electrolyte temperature was maintained between 20°C and 25°C. The detailed hydrogen charging plan is provided in TABLE 3, while the schematic diagram of the hydrogen charging apparatus is shown in Fig. 4(b).

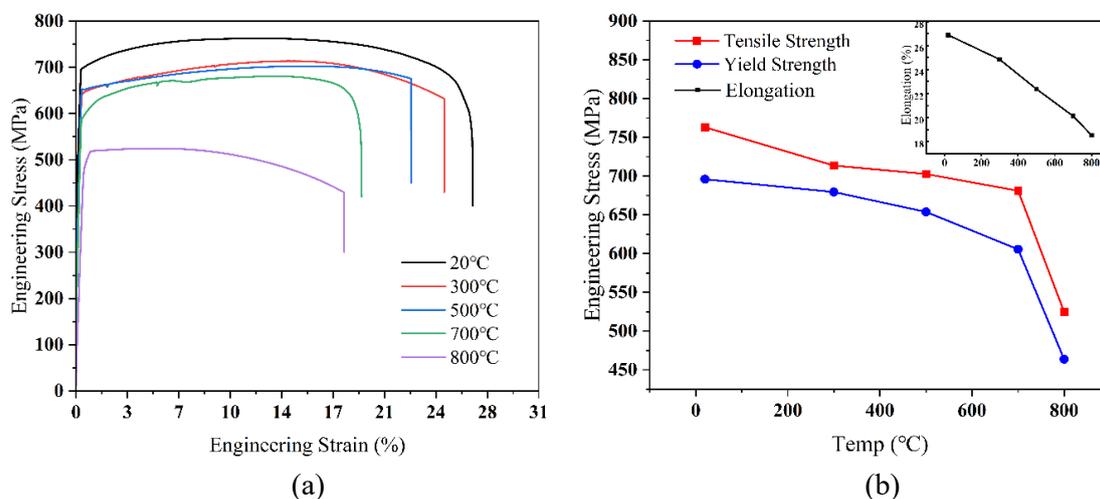
Fig. 5. Mechanical properties of Q690 weldments after various heat treatment temperatures (a) Stress-strain curves and (b) Mechanical parameters vs heat treatment temperature

During the heat treatment of high-strength steel, an increase in temperature within a specific range typically results in a gradual increase in grain size, which generally leads to a reduction in the steel's strength [24]. Fig. 5(a) presents the tensile stress-strain curves for Q690 high-strength steel weldments subjected to various heat treatment temperatures. The data show that the Q690 weldments without heat treatment at room temperature exhibit the highest tensile strength, yield strength, and elongation at break. However, as the heat treatment temperature increases, a noticeable decline in the material's mechanical properties is observed [25,26]. At elevated temperatures, fractures typically occur in the weld zone, which may be attributed to welding defects, such as porosity. When the post-fire joint is subjected to hydrogen exposure, the fracture location shifts to the heat-affected zone. This suggests that the weld joint becomes significantly more brittle at higher temperatures, which reduces the overall elongation of the welded material [27].

Fig. 5(b) shows the linear trends for the ultimate tensile strength ( $\sigma_b$ ), yield strength ( $\sigma_s$ ), and elongation at break ( $\delta$ ) of the material. It is important to note that when the heat treatment temperature reaches 800°C, the mechanical properties of Q690 welds drop to their lowest values. Specifically,  $\sigma_b$  decreases from the initial 763.09 MPa to 524.68 MPa,  $\sigma_s$  from 695.98 MPa to 463.71 MPa, and  $\delta$  from 26.88% to 18.52%. The reduction in tensile strength and yield strength of Q690 welds follows a consistent trend, although the decline is relatively gradual. It has been observed that, after high-temperature heat treatment, precipitates in the carbon-rich zones of welded joints become coarser and more numerous [28]. In welded joints, precipitation in carbon-rich zones leads to an increase in carbon content within the weld zone, which subsequently results in reduced material elongation. This effect is attributed to the carbon solution strengthening mechanism [29].

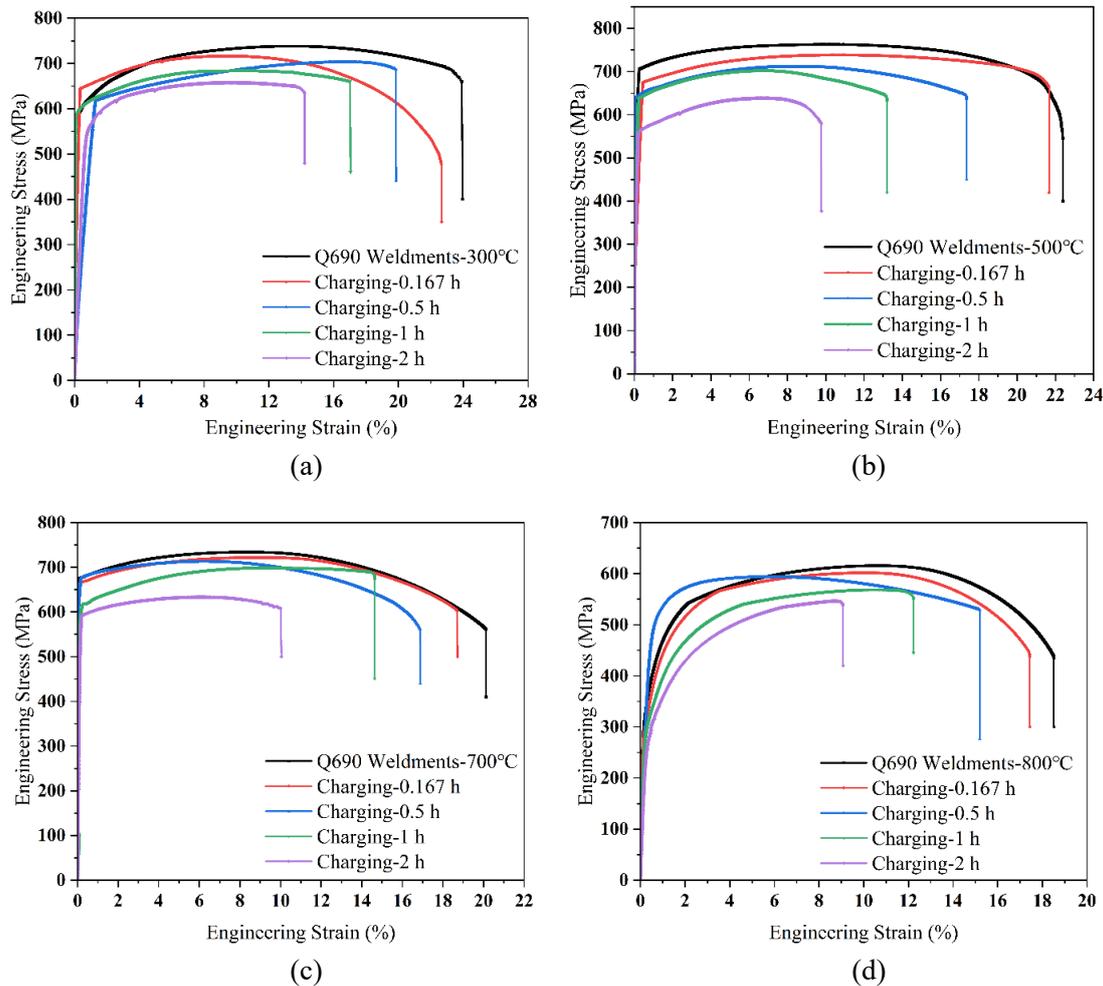
Fig. 6. Tensile diagram of mechanical properties of Q690 weldments with different hydrogen charging times. (a) 300°C, (b) 500°C, (c) 700°C and (d) 800°C

Fig. 6 presents the tensile test curves for Q690 high-strength steel weldments subjected to electrochemical hydrogen charging after various heat treatment temperatures. At 300°C, as hydrogen charging time increases, tensile strength gradually decreases (Fig. 6a). At 500°C, tensile strength and elongation 0.167 hours of hydrogen charging are similar to those of uncharged material. However, the elongation at break decreased significantly at the time of hydrogen charging for 2 h (Fig. 6b). These results for both uncharged and hydrogen-charged samples clearly show that electrochemical hydrogen charging significantly reduces both tensile strength and elongation, increasing susceptibility to hydrogen embrittlement [31]. As shown in Fig. 6(c), the tensile strength of welded parts without hydrogen charging at 700°C and those subjected to 0.167 hours of hydrogen charging are nearly identical. However, when the charging time is extended to 2 hours, both tensile strength and elongation decrease significantly. During electrochemical hydrogen charging, hydrogen atoms diffuse and accumulate at stress concentrators and localized defects, reduc-

ing toughness [32]. Hydrogen molecules enhance plastic sliding through the Hydrogen Enhanced Localized Plasticity (HELP) mechanism, promoting hydrogen-induced cracks and localized embrittlement [33,34]. Even with localized plastic deformation, hydrogen can lead to brittle fracture, further reducing the material's strength and elongation [35].

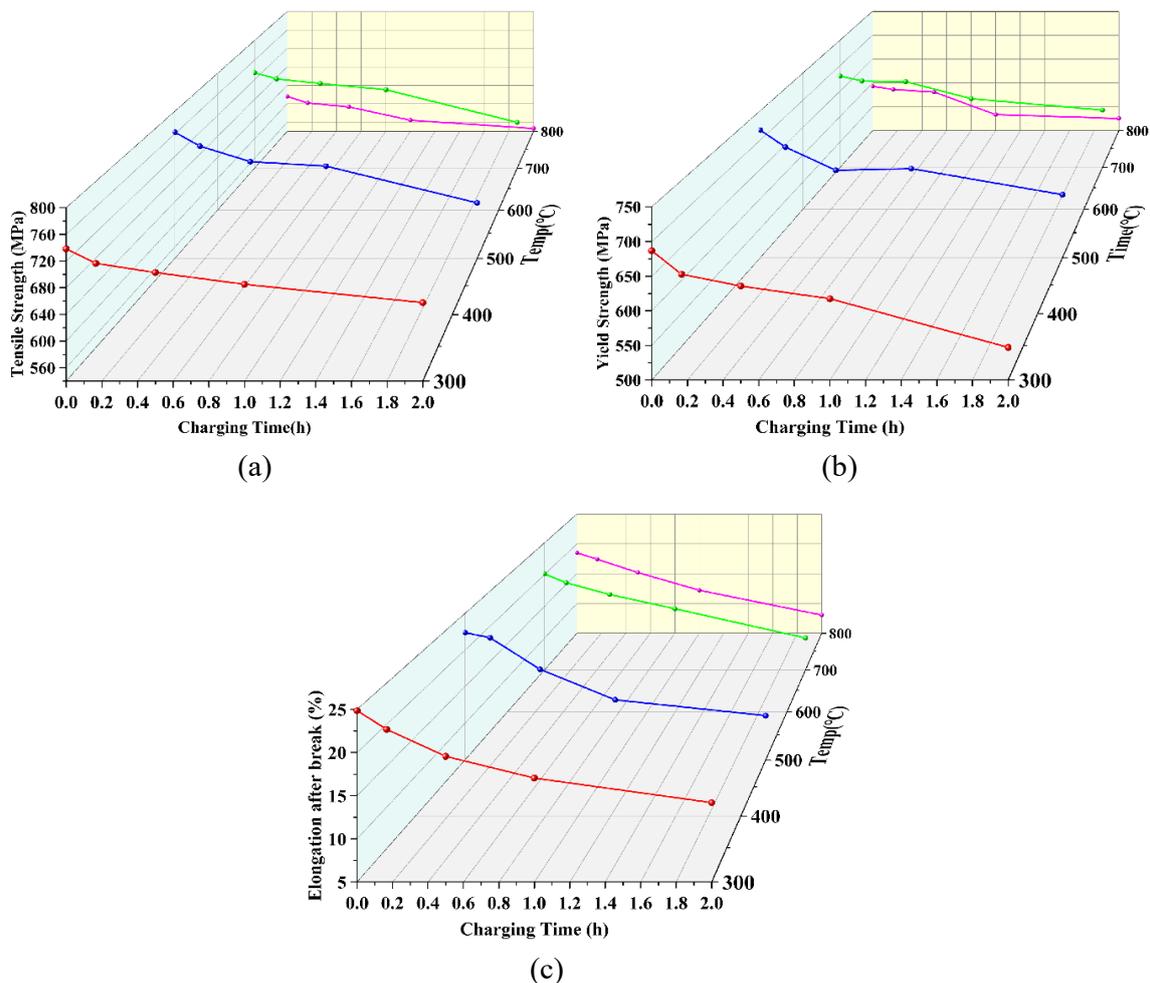
Fig. 7. Mechanical behaviors degradation of post-fire Q690 weldments with hydrogen charging time. (a) Tensile strength, (b) yield strength, and (c) elongation

Fig. 7 shows the variation in tensile strength (Fig. 7a), yield strength (Fig. 7b), and elongation at break (Fig. 7c) as a function of hydrogen charging time at different heat treatment temperatures. As seen in Fig. 7a, the tensile strength decreases consistently with increasing hydrogen charging time at all heat treatment temperatures. At 800°C, a significant strength reduction of about 8% is observed due to hydrogen exposure. Figs. 7b and 7c further illustrate the changes in yield strength and ductility. After heating to 800°C and charging with hydrogen for 2 hours, the yield strength of the Q690 high-strength steel welded parts is 525.17 MPa, and the ductility is 9.08%. Compared to the uncharged condition, yield strength decreases by approximately 11%, while elongation drops by about 51%. This substantial reduction in ductility may be attributed to the higher pearlite content and smaller grain size of the material, which alter its tensile behavior [36]. Molecular hydrogen significantly compromises both ductility and strength, promoting hydrogen-

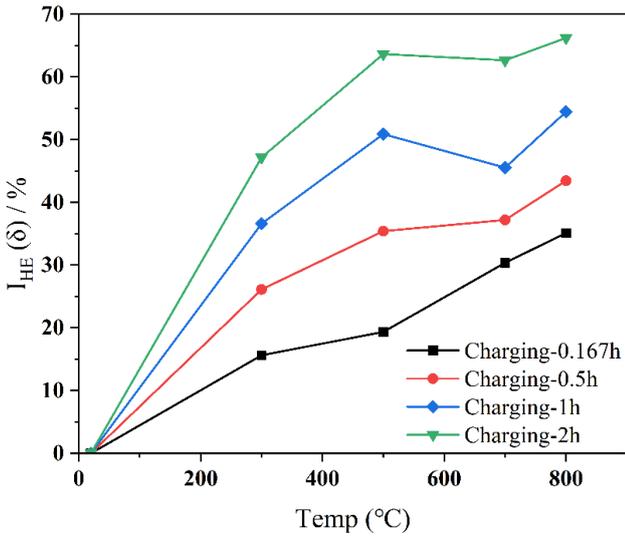
Fig. 8. Hydrogen embrittlement susceptibility index of post-fire Q690 steel

$\delta_0$  represents the elongation without hydrogen charging, and  $\delta_H$  denotes the elongation following hydrogen exposure. The rate of decrease in hydrogen-induced elongation of the material is encapsulated by  $I_{HE}(\delta)$ . A higher value of  $I_{HE}(\delta)$  indicates poorer resistance to hydrogen embrittlement and greater sensitivity to its effects. Fig. 8 shows the trend of the hydrogen embrittlement sensitivity index for Q690 high-strength steel weldments as the heat treatment temperature increases, under constant hydrogen charging time conditions. The data reveal that for any given hydrogen charging duration, the hydrogen embrittlement sensitivity coefficient of Q690 welded components increases consistently with temperature. Specifically, at a hydrogen charging time of 0.167 hours, the material's plasticity decreases, and its sensitivity to hydrogen embrittlement rises from 15.63% at 300°C to 35.12% at 800°C. When the hydrogen charging time is extended to 2 hours, the hydrogen embrittlement sensitivity index increases significantly, from 47.17% at 300°C to 66.22% at 800°C. According to the NASA 8-30744 [40] standard for assessing alloy hydrogen damage in the United States, the hydrogen embrittlement sensitivity index ( $I_{HE}(\delta)$ ) of the experimental steel exceeds 50% when the hydrogen charging time reaches 1 hour. This indicates severe hydrogen damage in the samples subjected to an electrochemical hydrogen charging duration of 1 hour. The diffusion depth of hydrogen can be calculated using the formula:

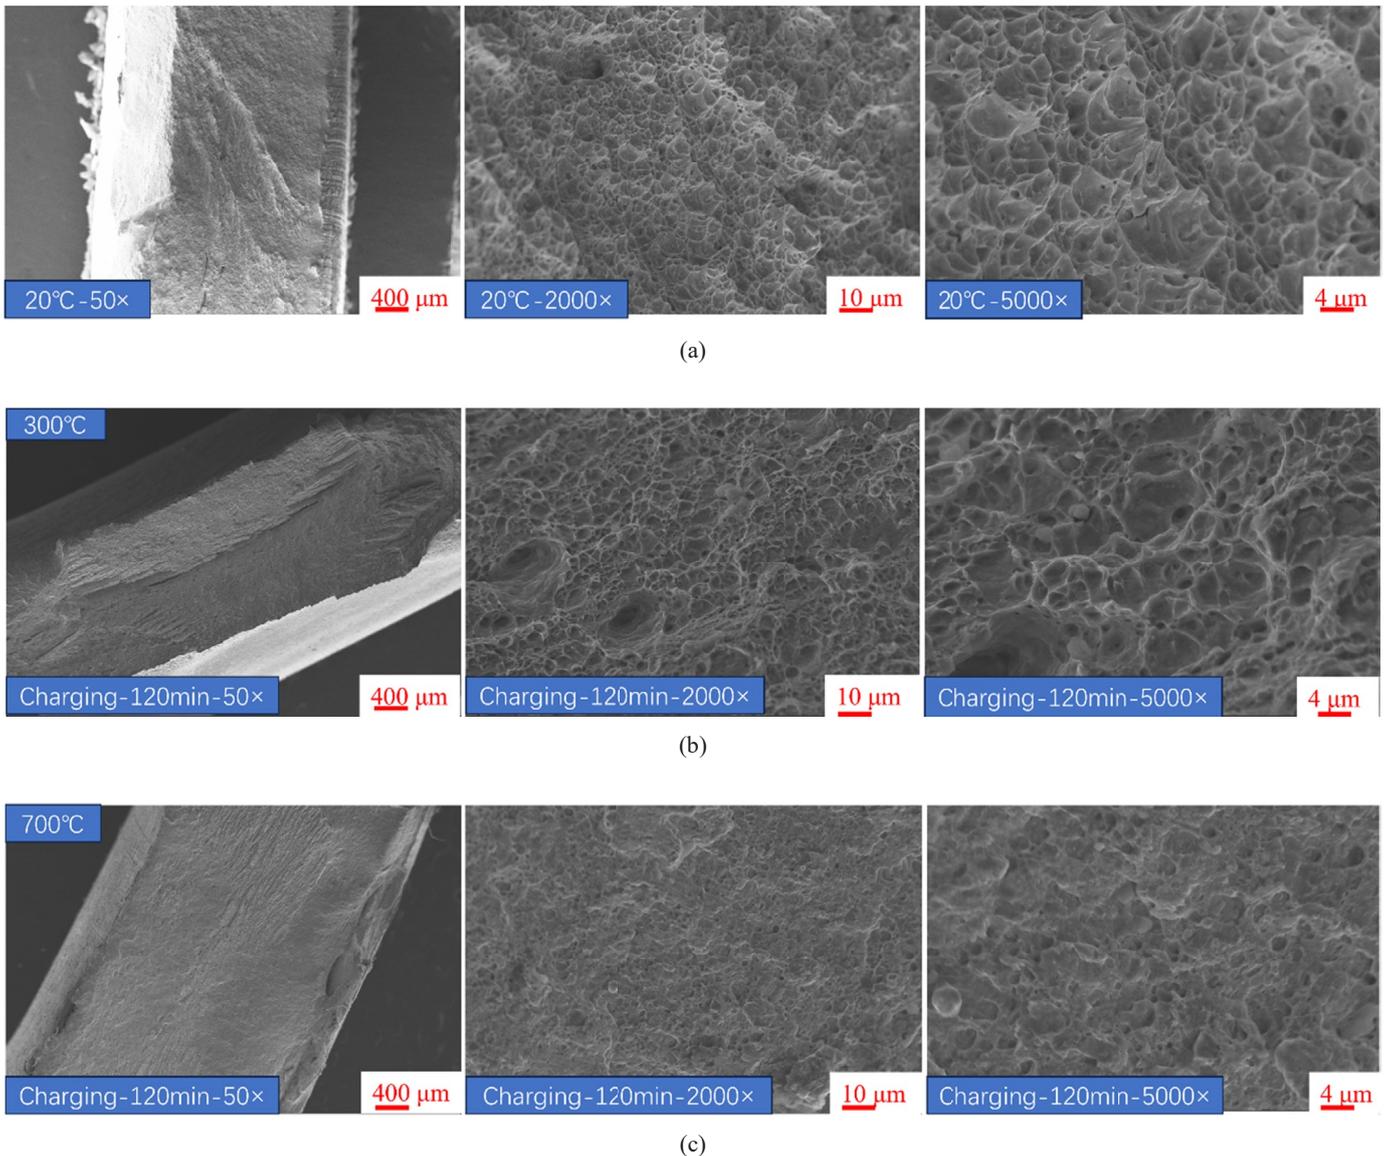
Fig. 9. Fracture morphology of hydrogen charging weldment with different heat treatment temperatures for 2h (×50, ×2000 and ×5000) (a) at 20°C, (b) at 300°C, (c) at 700°C

Fig. 9 shows scanning electron microscopy (SEM) images of the fracture surfaces of Q690 welded tensile samples subjected to different hydrogen charging times and heat treatment condi-

tions. Notably, the tensile fractures consistently occur within the heat-affected zone. As seen in the figure, the macroscopic fracture surface of the sample without hydrogen charging at room temperature is rough, while the microscopic fracture features multiple dimples (Fig. 9a), indicative of a typical ductile fracture with uniform size. At a heat treatment temperature of 300°C and 2 hours of hydrogen charging, the macroscopic fracture surface becomes smoother, with necking suggesting plastic deformation. Microscopic analysis reveals increased toughness pits, indicating that the sample has not yet reached complete brittle fracture. At higher temperatures (700°C) with 2 hours of hydrogen charging, the macroscopic fracture surface is flat and smooth, displaying corrugations and localized cracks. The microscopic fracture surface appears smoother after hydrogen charging. As the heat treatment temperature increases, the microscopic surface becomes rougher, adopting a relief-like structure. The hydrogen-charged samples fail through a deconstructive fracture mechanism, with widespread tearing and distinct brit-

tle fracture characteristics. These observations demonstrate that as the heat treatment temperature and hydrogen charging time increase, the extent of hydrogen damage intensifies, resulting in a gradual transition from ductile to brittle fracture.
