WEAR MECHANISMS ANALYSIS OF DIES USED IN THE PROCESS OF HOT FORGING A VALVE MADE OF HIGH NICKEL STEEL

The study presents a durability analysis of dies used in the first operation of producing a valve-type forging from high nickel steel assigned to be applied in motor truck engines. The analyzed process of producing exhaust valves is realized in the forward extrusion technology and next through forging in closed dies. It is difficult to master, mainly due to the increased adhesion of the charge material (high nickel steel) to the tool's substrate. The mean durability of tools made of tool steel W360, subjected to thermal treatment and nitriding, equals about 1000 forgings. In order to perform a thorough analysis, complex investigations were carried out, which included: a macroscopic analysis combined with laser scanning, numerical modelling by FEM, microstructural tests on a scanning electron microscopy and light microscopy (metallographic), as well as hardness tests. The preliminary results showed the presence of traces of abrasive wear, fatigue cracks as well as traces of adhesive wear and plastic deformation on the surface of the dies. Also, the effect of the forging material be

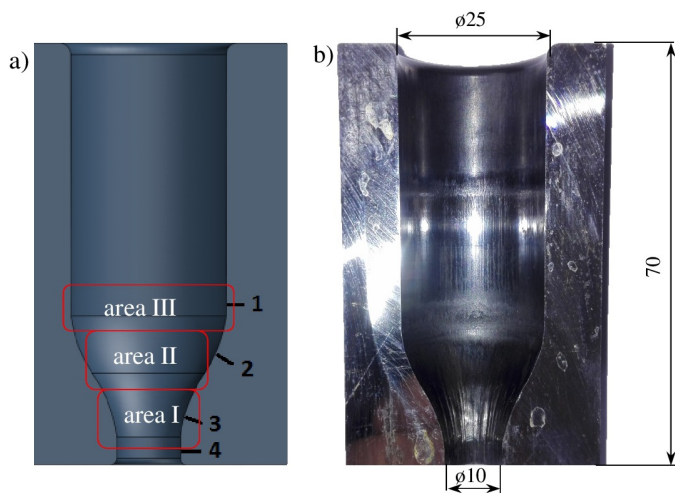
Fig. 2. View of the tool section: a) CAD model with marked selected measurement areas, including the microhardness test points, b) exemplary image of a die's half with main dimensions in mm

A detailed analysis was performed on dies used in I operation of hot forward extrusion of a long shank tipped with a preliminarily formed element called ‘bulb’. Fig. 2a shows a CAD model together with the distribution of the areas (measure points) of the surface of the tool section, for a better understanding and analysis of the obtained test results. Fig. 2b, in turn, presents an image of one half of a worn die.

In order to determine the effect of temperature on the state of the tools, the microhardness was measured in the function of the distance from the surface in 4 selected points (Fig. 2), which produced 900 and 1900 forgings. The comparison results for points no. 1 and no. 2 are presented in Fig. 22, whereas the comparison results for points no. 3 and no. 4 – in Fig. 23. The microhardness test results presented in Fig. in the function of the distance from the working surface of the die point to a diversified state of the tool surface layer in the particular areas of the analyzed tools. In point 1 (Fig. 2), where strong abrasive wear was observed (Fig. 3-4) as well as a material loss from the surface

layer, the hardness is lowered to about 900 HV at the surface after 900 forging cycles and to about 740 HV after 1900 forging cycles. This proves a gradual removal of the nitrided surface layer in the surface of the die. At the same time, the hardness analysis in point 2 (Fig. 2) showed that the tool, through the whole operation time, remains in this area without a loss of its mechanical properties. This is confirmed by the lack of abrasive loss in this region and the presence of only a few fatigue cracks on its surface. The performed analysis confirms that the stability of the nitrided layer in this area is still high.

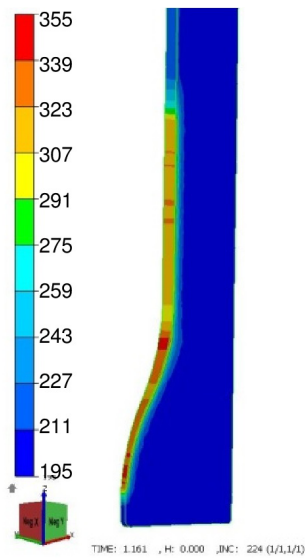
Fig. 7. Temperature distribution on the die in the last forging stage in °C

Fig. 7 shows the temperature field distributions on the die in the final forging stage.

Based on the presented results, it is possible to observe that the highest temperature is present in the area of intensive deformation of the charge material (reduction of forging section). It should be noted that due to the relatively small size of both the forging and the die, these elements have a very small thermal capacity, which may cause the conditions to dramatically change in the case of instability of the forging process, e.g. too long a shutdown, or overheating of the charge/die. This is especially visible in the case of the temperature field distribu-

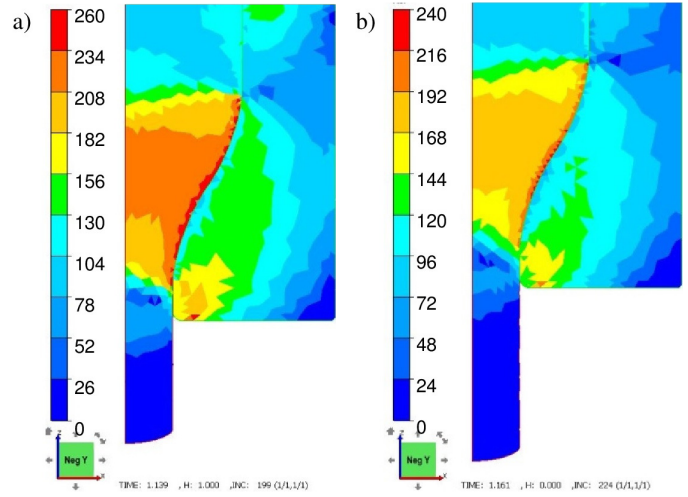
Fig. 8 Distribution of reduced stresses (von Mises): a) 1 mm to the full pocket of the punch, b) full pocket of the punch (last forging stage) in MPa

The presented distributions show not very high values of stresses, which should not cause the risk of plasticization or tool damage. The differences in the stress value can be explained by the fact that in the final stage the material fills the die pattern and the pressure is distributed on the whole surface. Much more information would be provided by the distributions of circumferential and radial stresses, as they are the ones which decide about a possible presence of longitudinal cracks on the die, which, in turn, could correlate with the cracks observed in the macro- and microstructural tests. Fig. 9 shows the path of friction on the die in the last forging stage. Based on the presented results, we can conclude that the area in the die through which the most material

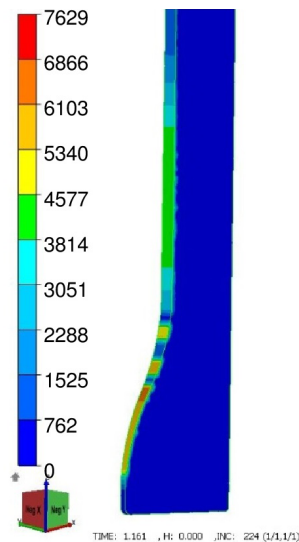
Fig. 9. Path of friction in the last extrusion stage in MPa mm

of the formed forging flows is the area which is the key zone for the process, where ridging occurs as a result of scale friction and sticking of the forging material.
