M.M. LACHOWICZ^{1*}

IMPACT OF THE PLASTIC DEFORMATION MICROSTRUCTURE ON THE CORROSIVE RESISTANCE OF METALLIC MATERIALS – THE STATE OF THE ART AND THE EFFECT OF MICROSTRUCTURE REFINEMENT ON THE EXAMPLE OF THE 2000 SERIES ALUMINUM ALLOY

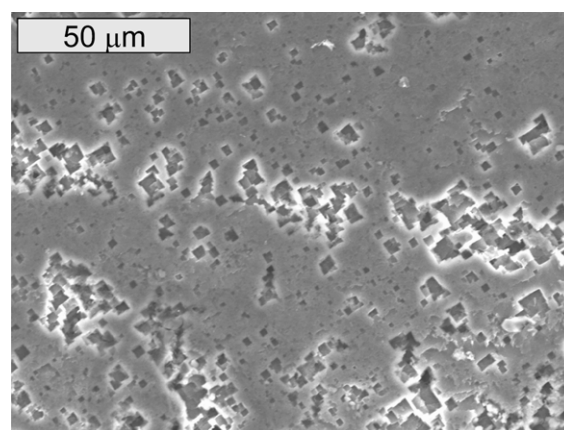
Fig. 1. A general view of a "crystallographic attack" observed in the solid solution of aluminium alloy AW7075 [unpublished own materials]

directions. Planes belonging to those densely packed with atoms demonstrate the lowest value of potential of pitting corrosion initiation, and so they are the most prone to pitting corrosion initiation [35,36]. An exemplary view of a crystallographic attack observed after corrosion tests in alloy AW7075 has been presented in Fig. 1. The literature shows that reaching the plane wall (100) stops the corrosion process due to the fact that it is the plane with the highest thermodynamic stability and the most resistant to dissolution in reference to planes (011) and (111) [34]. Treacy et al. [35] point out that the propagation of pits on the surface of (100) requires dissolution of the most tightly bound (111) subsurface atoms, which cause the crystallographic plane (100) to be more resistant to a pitting attack. In the aspect of the issue discussed above, we should expect that the texture present in the material caused by metal forming will significantly affect the general corrosion of metallic materials.

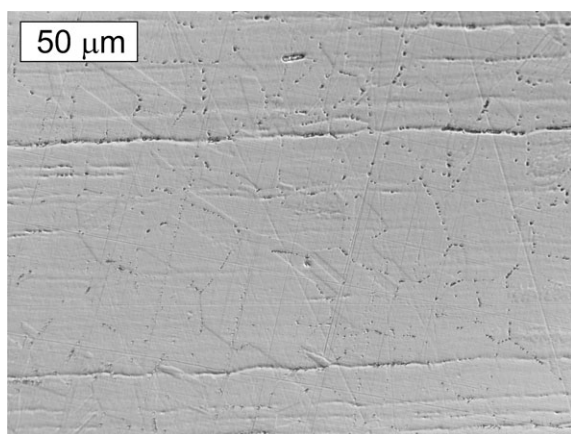
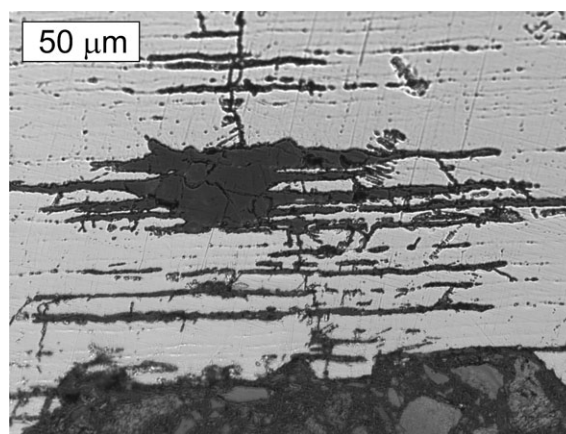
Fig. 2. Stress corrosion cracking (SCC) of austenitic stainless steel X5CrNi18-10: a) the microstructure with carbide precipitates arranged along the plastic deformation direction and present on the grain boundaries; b) an advanced stage of SCC. Visible locally selective character of corrosion conditioned by the presence of carbide bands. Light microscopy, etched state with a 10% aqueous solution of oxalic acid [unpublished own materials]

At the microscopic level, the heterogeneous microstructure with bands can affect the differentiation of the corrosion mechanism in individual areas of the material. This effect can be observed, for example, in Fig. 2, which shows the course

of stress corrosion cracking (SCC) in austenitic stainless steel X5CrNi18-10 grade. A characteristic property of the formed cracks is their strong branching (resembling a tree root) as well as orientation perpendicular to the maximal tensile stresses. The formed crack becomes an active anode, which catalyzes a further development of corrosion. In the presented case, the number of branches connected with SCC is small, due to the presence of band-oriented precipitates of carbides as well as ferrite δ in the structure of the examined metal sheet. This contributed to a local occurrence of selective corrosion. The forming crack created a path for the corrosive solution, which released other corrosion mechanisms, at the same time limiting the number of cracks caused by SCC.

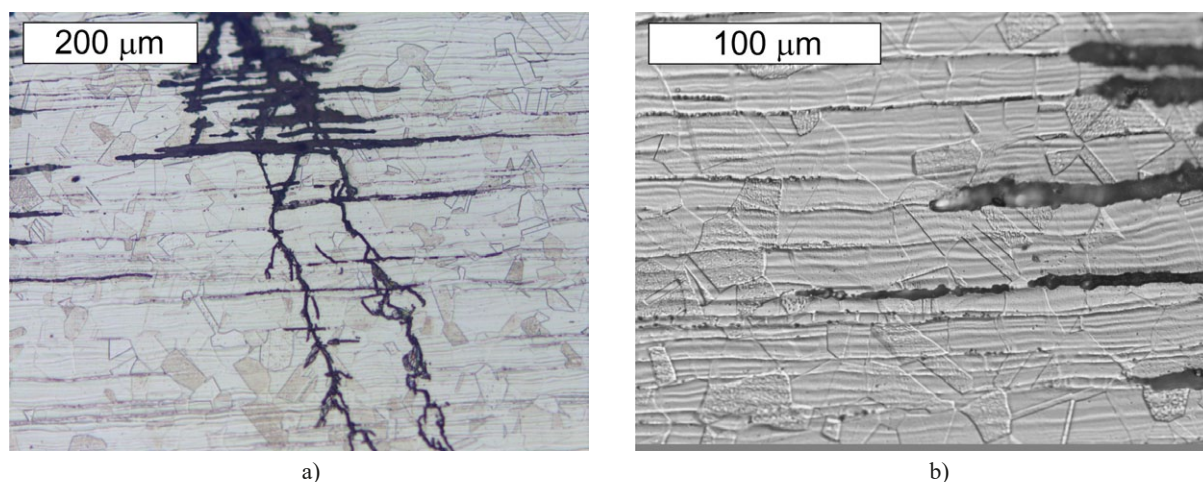
Fig. 3. a) SCC of austenitic stainless steel X5CrNiMo17-12-2; b) a magnified fragment of the area with ferrite δ showing the development of selective corrosion. Light microscopy, etched state with a 10% aqueous solution of oxalic acid [unpublished own materials]

A similar effect has been observed in the case of austenitic stainless steel X5CrNiMo17-12-2, shown in Fig. 3. Also in this case, selective corrosion was observed, caused by the presence of ferrite δ . However, here, the degree of selective corrosion

advancement was clearly lower. The cracks caused by SCC obtained a more branched form.

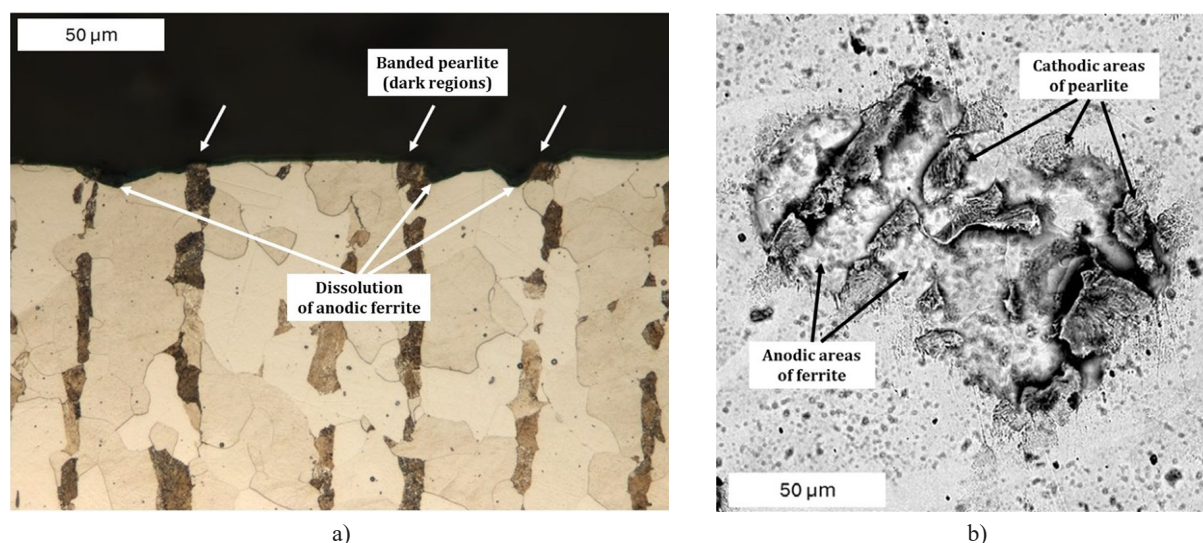
Fig. 4. a) Banded ferritic-pearlitic steel. A cross-section made of a sample after electrochemical tests. Visible dissolution of the anodic ferrite areas while maintaining the cathodic pearlite unchanged. The arrows mark the places where pearlite occurs. Light microscopy, etched state with 3% Nital; b) The surface of the same steel after electrochemical tests. Bands of pearlite as a result of ferrite dissolution are visible. SEM [unpublished own materials]

At the macroscopic level, such banded microstructure may manifest itself in anisotropy in the development of corrosion, influencing the nature of the features in the explosive surface layer. This effect can be observed, for example, in banded ferritic-pearlitic steel (Fig. 4).

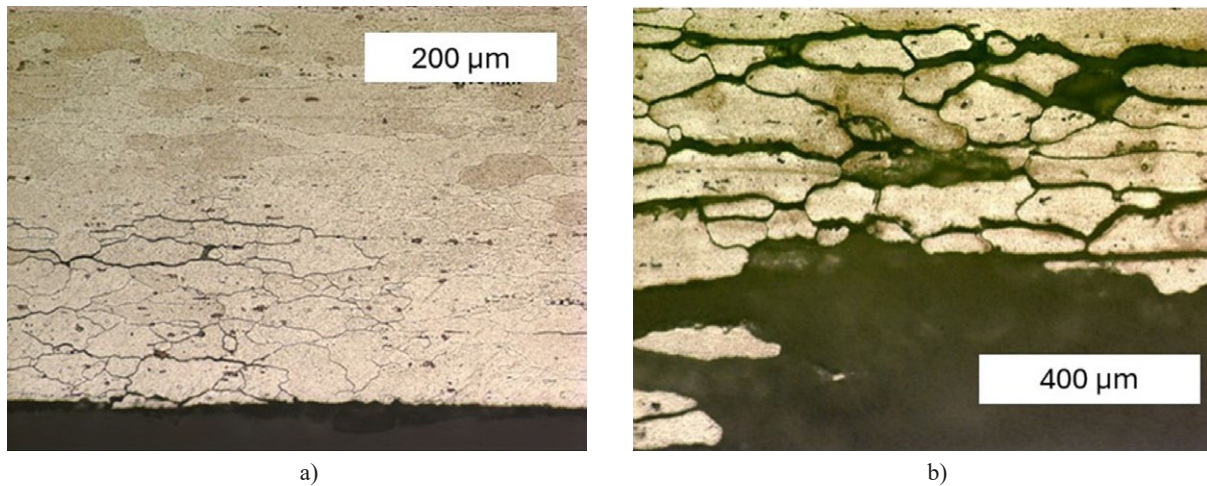
Fig. 5. a) Advanced exfoliation of AW2017A aluminium alloy on the longitudinal-section in respect of the plastic deformation. b) An enlarged fragment of the microstructure in the near-surface area Light microscopy, etched state with a 2% HF aqueous solution [unpublished own materials]

present on the grain boundaries, which, in turn, leads to their cracking and, ultimately, to lifting of the alloy's whole surface layers. This effect can be observed, for example, in Fig. 5. The grain boundaries formed longitudinally to the plastic deformation direction become active zones responsible for the penetration and transport of the corrosive solution into deeper areas of the aluminium components. The alloy's pulverization occurring in grains arranged according to the plastic deformation direction favours surface exfoliation in products made of alloys from the 2000 series [8,37,39].

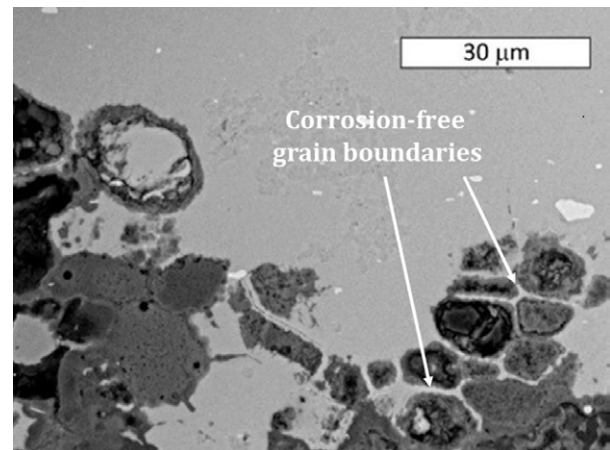
Fig. 6. Exfoliation features in the AW2017A aluminium alloy on the cross-section in respect of the plastic deformation, non-etched state. SEM [8]

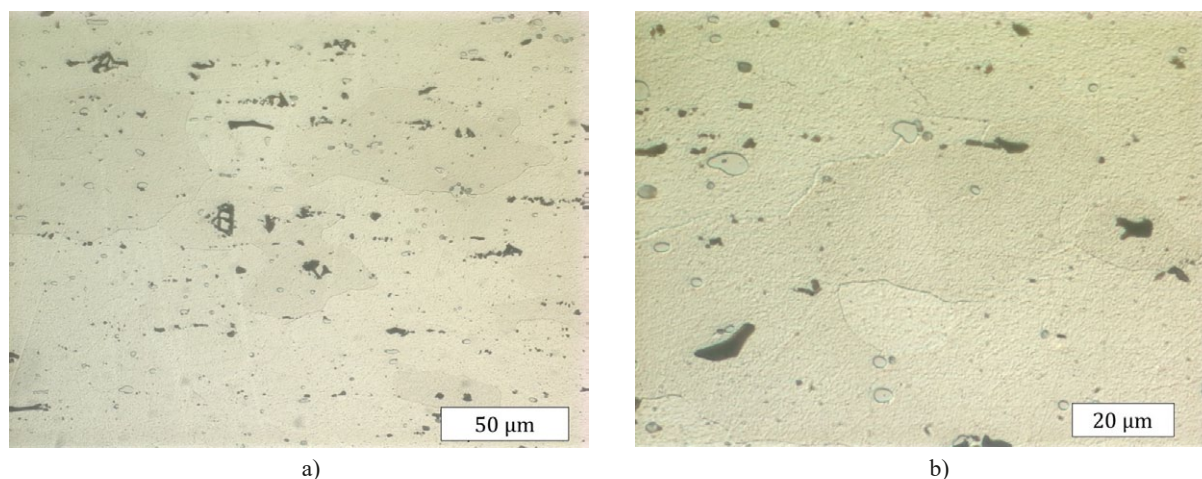
Fig. 7. a) Microstructure of the examined aluminium alloy AW 2017A - T451. Visible precipitates of phase α -AlFeMnSi (dark colour, in the microscopic image) and single primary precipitates of phase Al₂Cu (θ) in the aluminium solid solution. b) A magnified fragment of the area from Fig. a, Light microscopy, etched state

The performed metallographic tests of alloy AW2017A demonstrated that its microstructure was characteristic of wrought aluminium alloys. It consisted of aluminium solid solution grains with precipitates of intermetallic phases (Fig. 7). The irregular precipitates observed in a light microscopic image constitute phase α -AlFeMnSi (grey, in the light microscopy image). Also observed were single globular primary precipitates of phase Al₂Cu (light colour, in the microscopic image). Detailed metallographic tests have been presented in [8]. The hardness

of the material as-delivered equalled 115 ± 7 HV3, which is confirmed by the state of delivery.

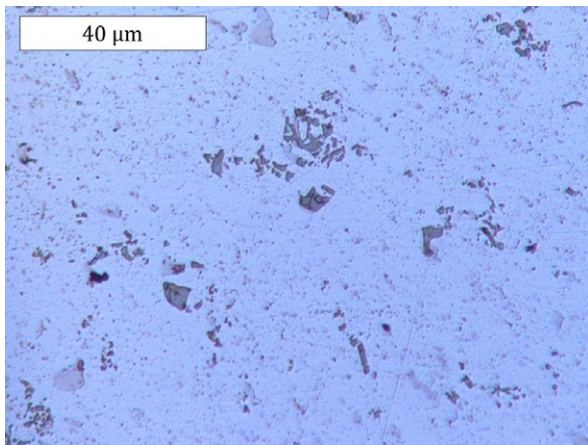
Fig. 8. Microstructure of the examined as-cast alloy from the Al-Cu system. Visible irregular precipitates of phase α -AlFeMnSi(Cu) and single primary precipitates of phase Al₂Cu. Light microscopy, Nomarski contrast, etched state

The microstructure of the as-cast alloy Al4CuMgSi (AC2017A) was constituted by irregular precipitates of a phase rich in iron α -AlFeMnSi and globular precipitates of phase θ -Al₂Cu in the aluminium solid solution (Fig. 8). Precipitates of phase Al₂Cu in casting alloys have also been observed by other authors [40,41]. They occurred both in the form of large block-like precipitates and fine dispersive ones, whose formation is favoured by a high cooling rate or heterogeneous nucleation [41]. According to the expectations, the density of their presence was clearly lower than in the case of an alloy after plastic deformation.

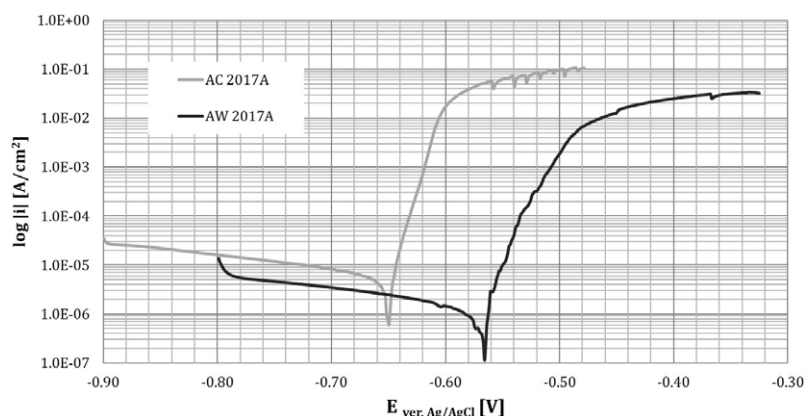
Fig. 9. Exemplary potentiodynamic polarization curves obtained for wrought alloy AW 2017A and as-cast alloy AC 2017A

In the case of both alloys, the course of the anodic reaction exhibited an intensive increase, which points to a significant rate of their general corrosion. However, significant differences in the obtained polarization curves were observed. The alloy as-cast demonstrated a lower value of corrosion potential E_{corr} , as well as higher values of anodic currents compared to alloy AW2017A in state T451. This proves a more intensive oxidation reaction taking place on the surface of the as-cast alloy. A higher value of corrosion current i_{corr} translates to a higher corrosion rate of alloy AC2017A. Both alloys corroded under cathodic control, that is, the oxidation reaction took place “more easily” than the reduction reaction.

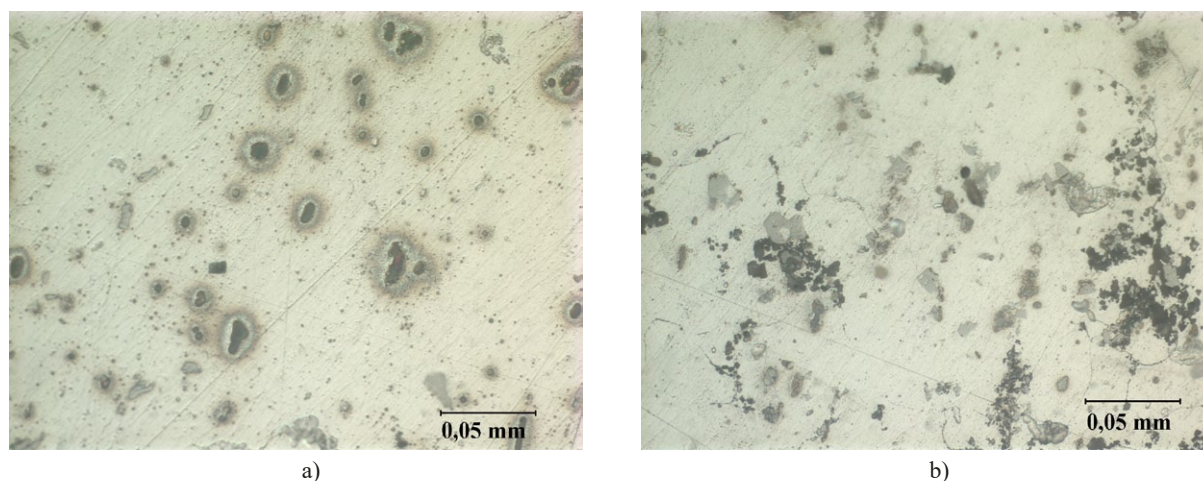
Fig. 10. A macroscopic image of the sample surface of alloy AW2017A as-delivered after electrochemical tests: pitting corrosion, b) an attack on the grain boundaries. Stereoscopic microscopy

of the sample surfaces of the alloy in both states after they underwent local corrosion. In the case of alloy AW2017A, the presence of dispersive cathodic precipitates of phase Al_2Cu in the grains surrounded by a zone depleted of copper leads to selective dissolution of the aluminium solid solution, which predisposes the alloy for changes in the form of general pitting corrosion (Fig. 10). The initiation of corrosion at a macroscopic level is connected with the formation of corrosion micro-pits in the areas of the presence of large intermetallic precipitates (Fig. 11). Also observed was a corrosive attack of the grain boundaries (marked with arrows), which points to sensitization of the grain boundaries. The microscopic observations SEM showed that the corrosion of the solid solution has the character of a crystallographic attack (Fig. 10). While growing, these changes occupy an increasing area of the substrate surface. This will be favoured by the presence of a big amount of fine-dispersive precipitates of the precipitate-hardening phase, which, though invisible in a microscopic image, will be present in state T451. Observations performed with higher magnifications show that precipitates of phase Al_2Cu were cathodically

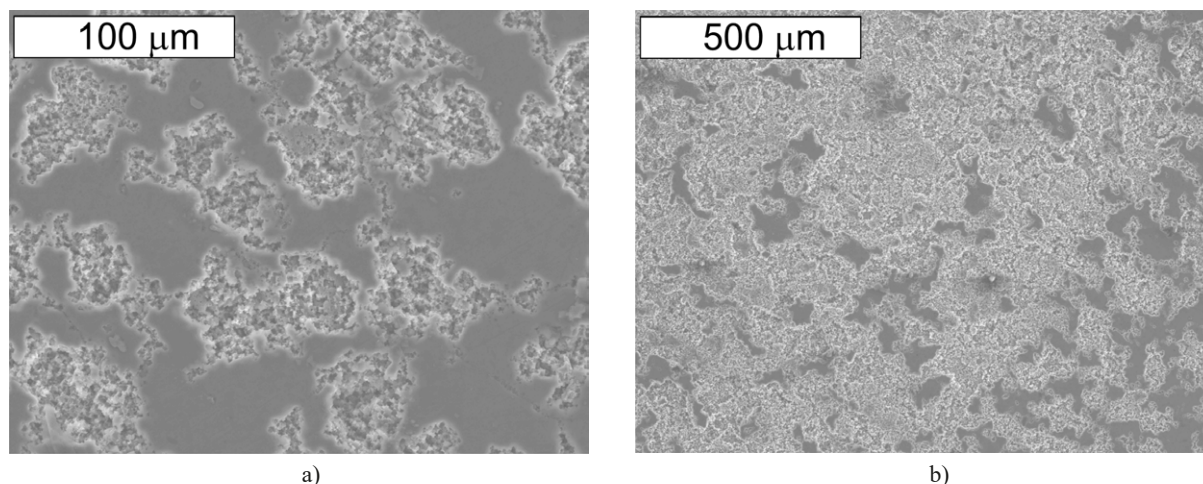
Fig. 11. An image of the sample surface of alloy AW2017A as-delivered after electrochemical tests finished at the potential of: a) +150 mV, b) +250 mV in respect of E_{corr} . SEM

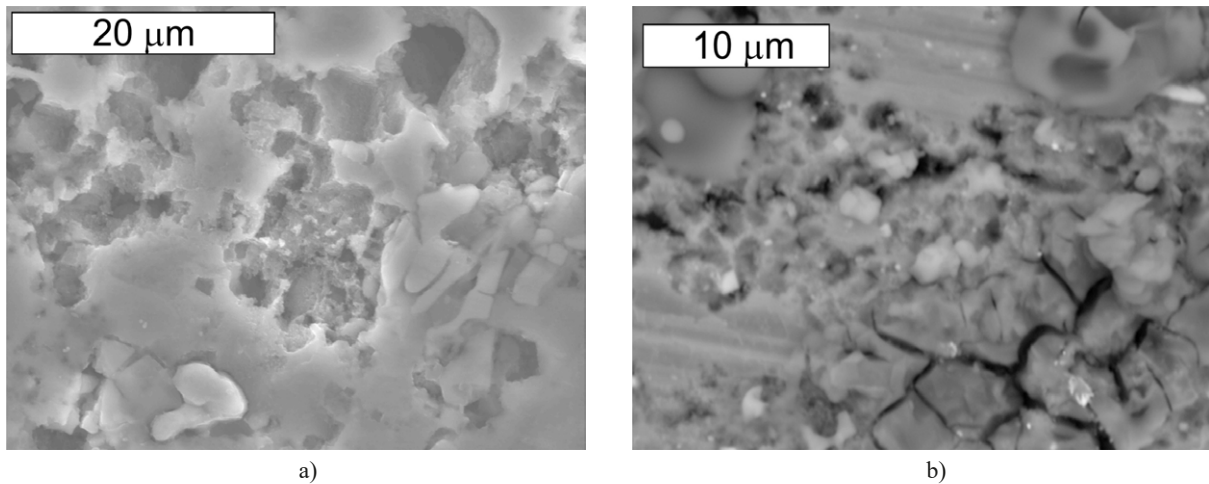
Fig. 12. An image of the sample surface of alloy AW2017A as-delivered after electrochemical tests finished at the potential of: a) +150 mV, b) +250 mV in respect of E_{corr} . SEM

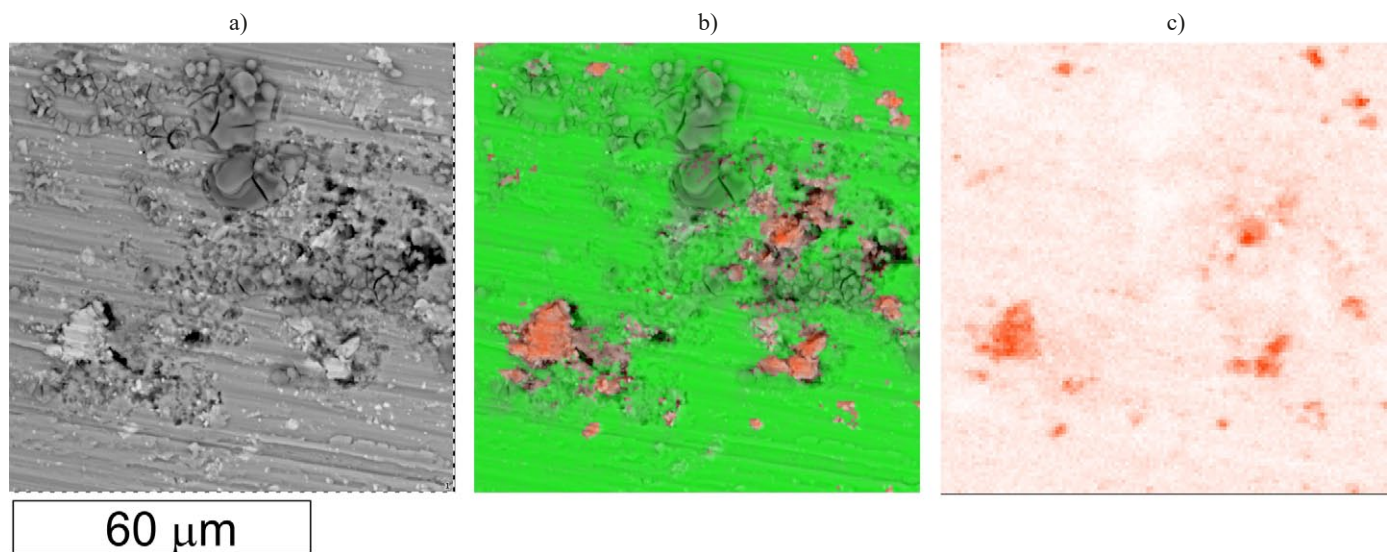
Fig. 13. a) A microscopic image SEM of the sample surface of alloy AC2017A as-cast after electrochemical tests finished at the potential of +150 mV in respect of E_{corr} . Visible aluminium solid solution dissolution around the cathodic precipitates of phase Al_2Cu present in the microstructure of alloy AC2017A, b) a SEM image from Fig. a compiled with the aluminium and copper distribution obtained by the EDS method, c) the copper distribution on the surface of the area shown in Fig. a

The microscopic observations conducted after the electrochemical tests of alloy AC2017A confirm a similar effect of phase Al_2Cu on the occurring corrosion processes, also in the case of as-cast alloy AC2017A. However, the large precipitates present in the microstructure favour corrosion of the solid solution mainly in their own surrounding (Fig. 13). This

leads to much deeper changes than in the case of the alloy after plastic deformation, and, at the same time, it clears the path for the corrosive solution. This type of circumferential damage present around the cathodic phase is described in the literature as “cathodic corrosion” [42]. Corrosion initiated around the precipitates may lead to a loss of coherence and the formation of micro-pits on the surface of the corroding element. In such a case, the large and hard particles of phase Al_2Cu moving into the working area favour a possible tribological destruction of the details cooperating with it. The surface changes occurring as a result of cathodic precipitates, if they are distributed inside the grains, can be of big importance, not for a material loss caused by corrosion, but rather as potential areas of initiation of corrosive fatigue and formation of fatigue cracks. There are experimental data which confirm that corrosive cracking is often initiated in areas with corrosive pits [43].
